Effects of electric power blackouts on steam turbine power plants

Damages caused by power blackout at Khartoum North Thermal Station

Table 3: The mechanical parts damaged by blackout phenomenon in Bahri Thermal Station

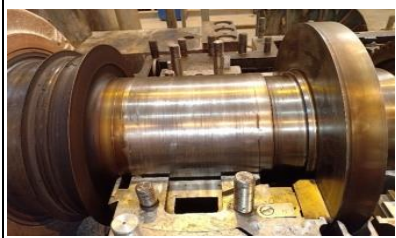
Mechanical parts damaged	Damage details	Action to be taken	figures
HP TURBINE ROTOR	Scoring line marks observed on HP Turbine rotor front journal area.

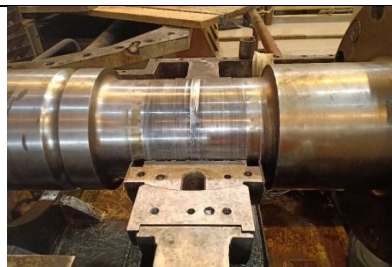
LP Turbine front journal	Heavy deep scoring line marks were observed on LP front journal area.	Polishing of the LP front journal to remove the existing scoring. This will in turn reduce the size of the Journal.

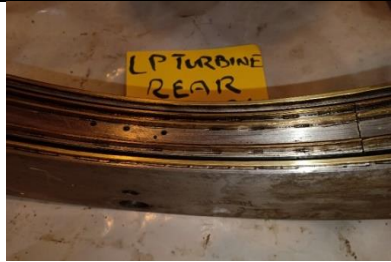
LP Turbine rear oil gland	Oil gland fins got damaged due rubbing	<ul style="list-style-type: none"> - Oil gland (Segments) to be replaced with new one. - Oil gland to be sent to STS work shop in India.

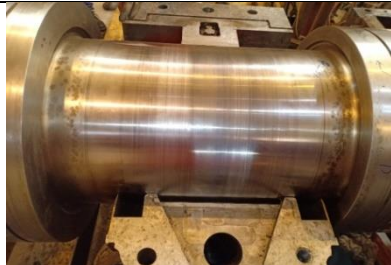
Generator rotor front journal	Minor Scoring line marks observed on journal area	Polishing of the LP front journal to remove the existing scoring. This will in turn reduce the size of the Journal.

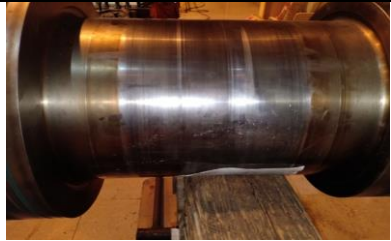
Generator rear journal	Minor Scoring line marks observed on Rear journal area	Polishing of the LP front journal to remove the existing scoring. This will in turn reduce the size of the Journal.

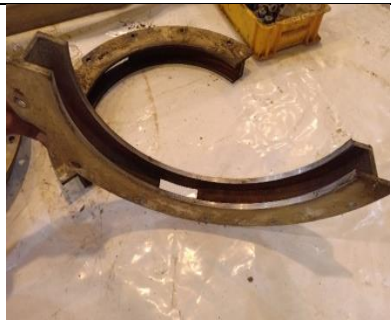
Generator air seal	<ul style="list-style-type: none"> - Generator front and rear air seal got damaged due to rubbing. - Exciter Air seal fins got damaged due rubbing. 	<ul style="list-style-type: none"> - Replacement air seals with new one. Old air seals to be sent to STS Work shop in India for revers engineering Description
