PALU EARTHQUAKE CASE STUDY: INDUCING AND PRINCIPLE OF ITS COUNTERMEASURES

Sandy Radhitya Akbar¹, Eddie Sunaryo², Asep Setiawan³

^{1,2,3}Civil Engineering Department, Faculty of Engineering, Widyatama University, Indonesia

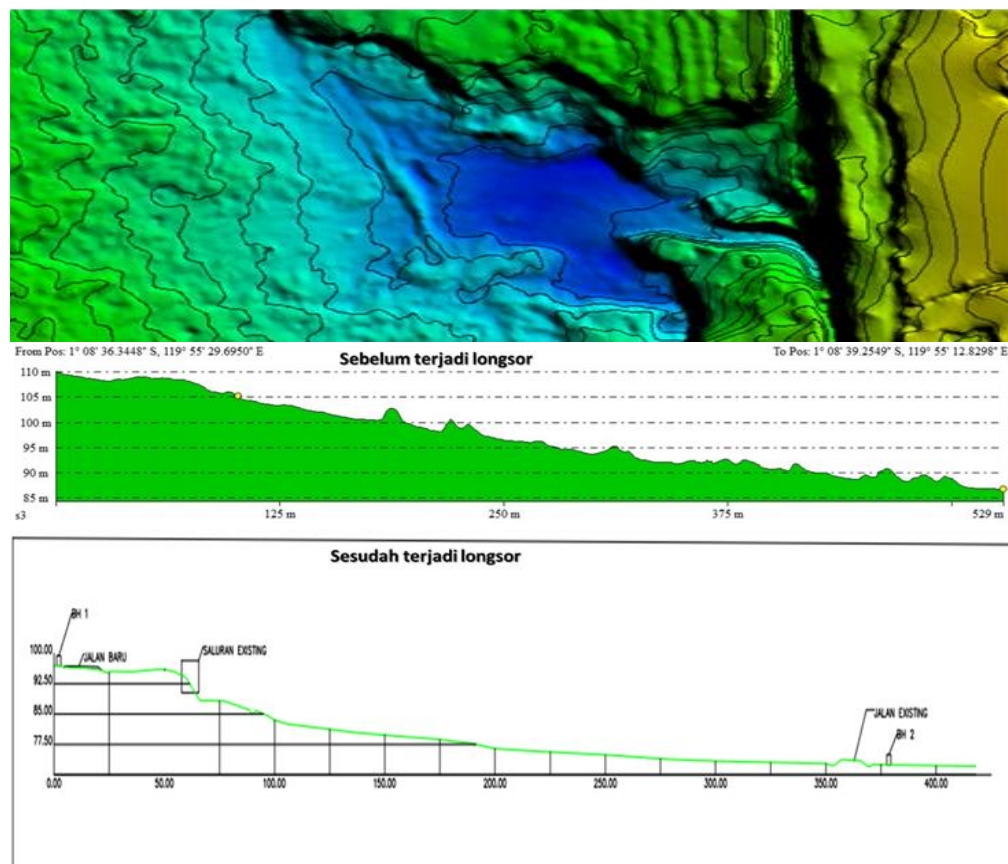
- a) Based on the results of field measurements both manually and by DTM (Digital Elevation Modeling) and GCP (Ground Control Point), it shows that landslides occurred on gentle slopes with unconfined soils, and are shown in Fig. 3.
- b) The study and evaluation of the Sibalaya location shows that the landslide location was caused by the accumulation of water with great pressure and was stuck on the hills formed during the tectonic process that had taken place before.

Figure 3 Cross sections at the Sibalaya location (before and after landslides) due to the Palu earthquake [2]

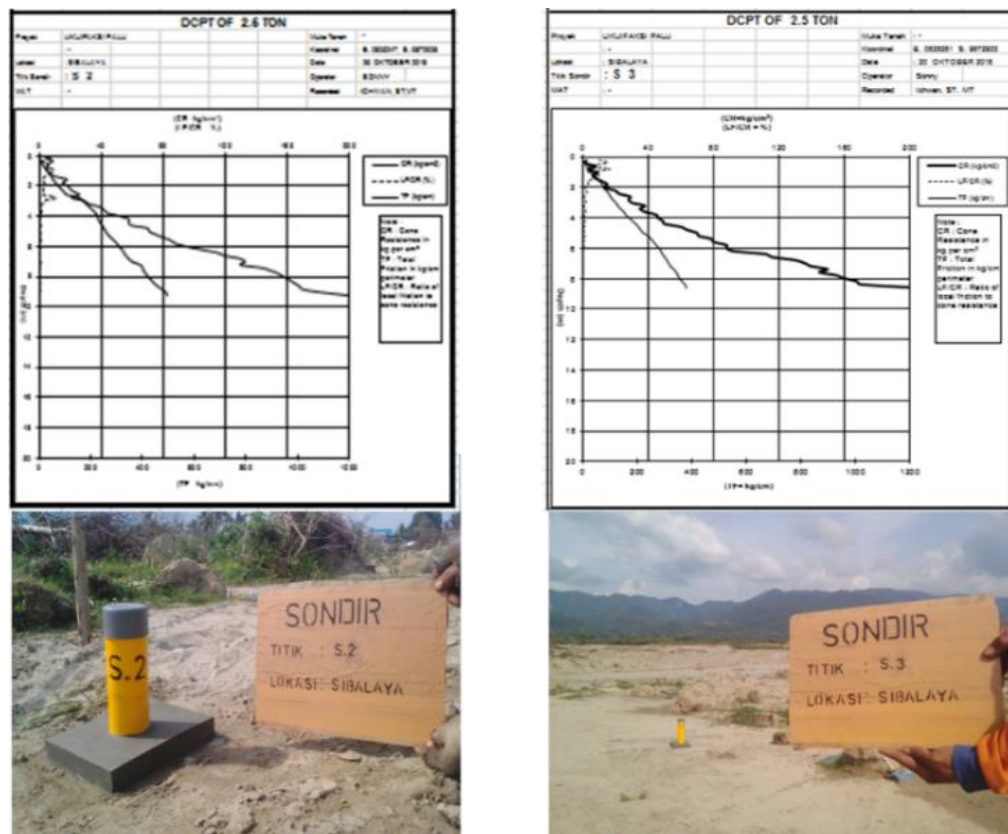
Based on several results of field investigations conducted, some data were obtained which were used for seismic analysis and other impacts such as Tsunamis, Liquefaction, Landslides and Land subsidence. The results of the investigation by CPT (Cone Penetrometer Test) or sondir showed that the depth of the hard soil layer was obtained at a depth of 10 m from the local soil surface. The result of the end resistance value (qc) > 1500 kPa is quite shallow and this shows that the unsaturated state has a large bearing capacity. When further observed the gradation as shown in Figure 4, this material has various grains and is very sensitive to the potential for liquefaction, especially due to changes in the saturation process accompanied by increased pressure (confined pressures).

Figure 4 CPT values from site

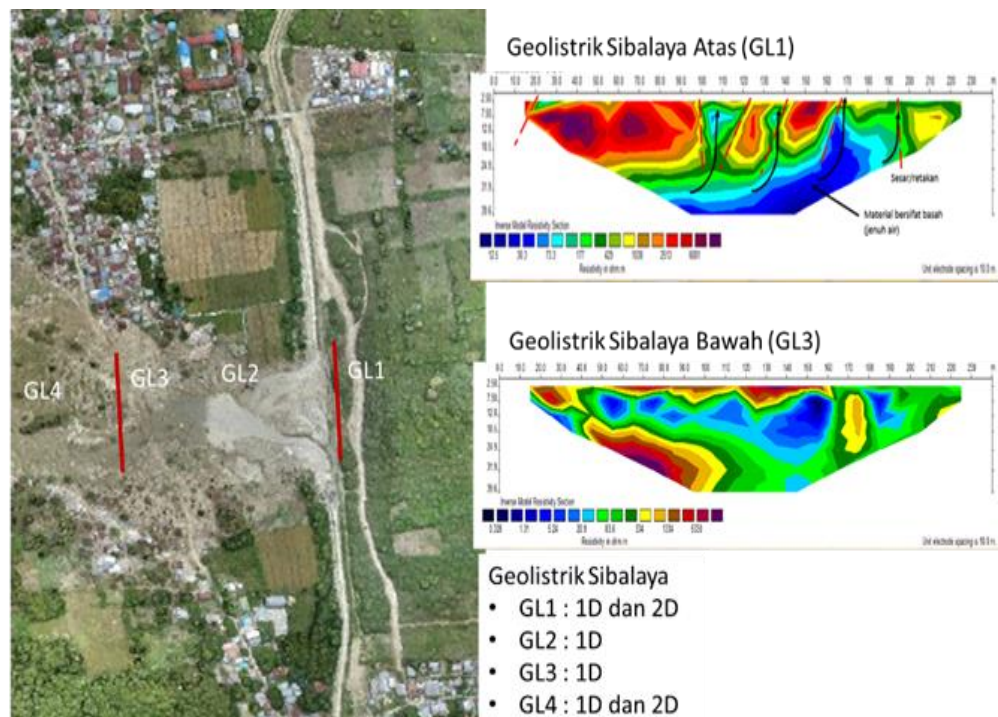
From the geoelectric test of GL1 (Figure 5), the upper part is adjacent to a secondary irrigation canal whose presence is suspected to be in the minor fault area of the Palu-Koro major fault. This layer provides information on the presence of an unfettered and easily intrusive layer that originates underneath. This condition is indicated by the existence of springs that pass through the fracture and partially saturate and melt the unconfined sand layer of Molasse to find a way out, resulting in liquefaction of the soil (liquefaction process).

From the geoelectric test of GL3 at the bottom, it is found that a layer of loose, saturated sand is spread out with a relatively shallow depth with loose and saturated conditions because it is no longer confined so that it experiences movement (landslide), there are 3 main layers of GL:

- 1) Layer 1 ± 5 meters - 25 meters with a resistivity value of 1038 Ωm - 6081 Ωm is a layer of molasses and stockpile soil (Unconfined and Confined Molasse layers)
- 2) Layer 2 with a resistivity of 177 Ωm - 429 Ωm at a depth of ± (25 meters - 32 meters): the sandy mud layer with its constituent lithology is silt with a mixture of sand in it (impermeable layers as Film Layers)

3) Depth ± (32 meters - 39.6 meters) with a resistivity value of 12.5 Ωm - 73.3 Ωm: The lithology of this layer is thought to be mud or mud rock having a higher moisture content than other lithologies (the presence of claystone / clay-shale layers).

Figure 5 Geoelectrical resistivity test results

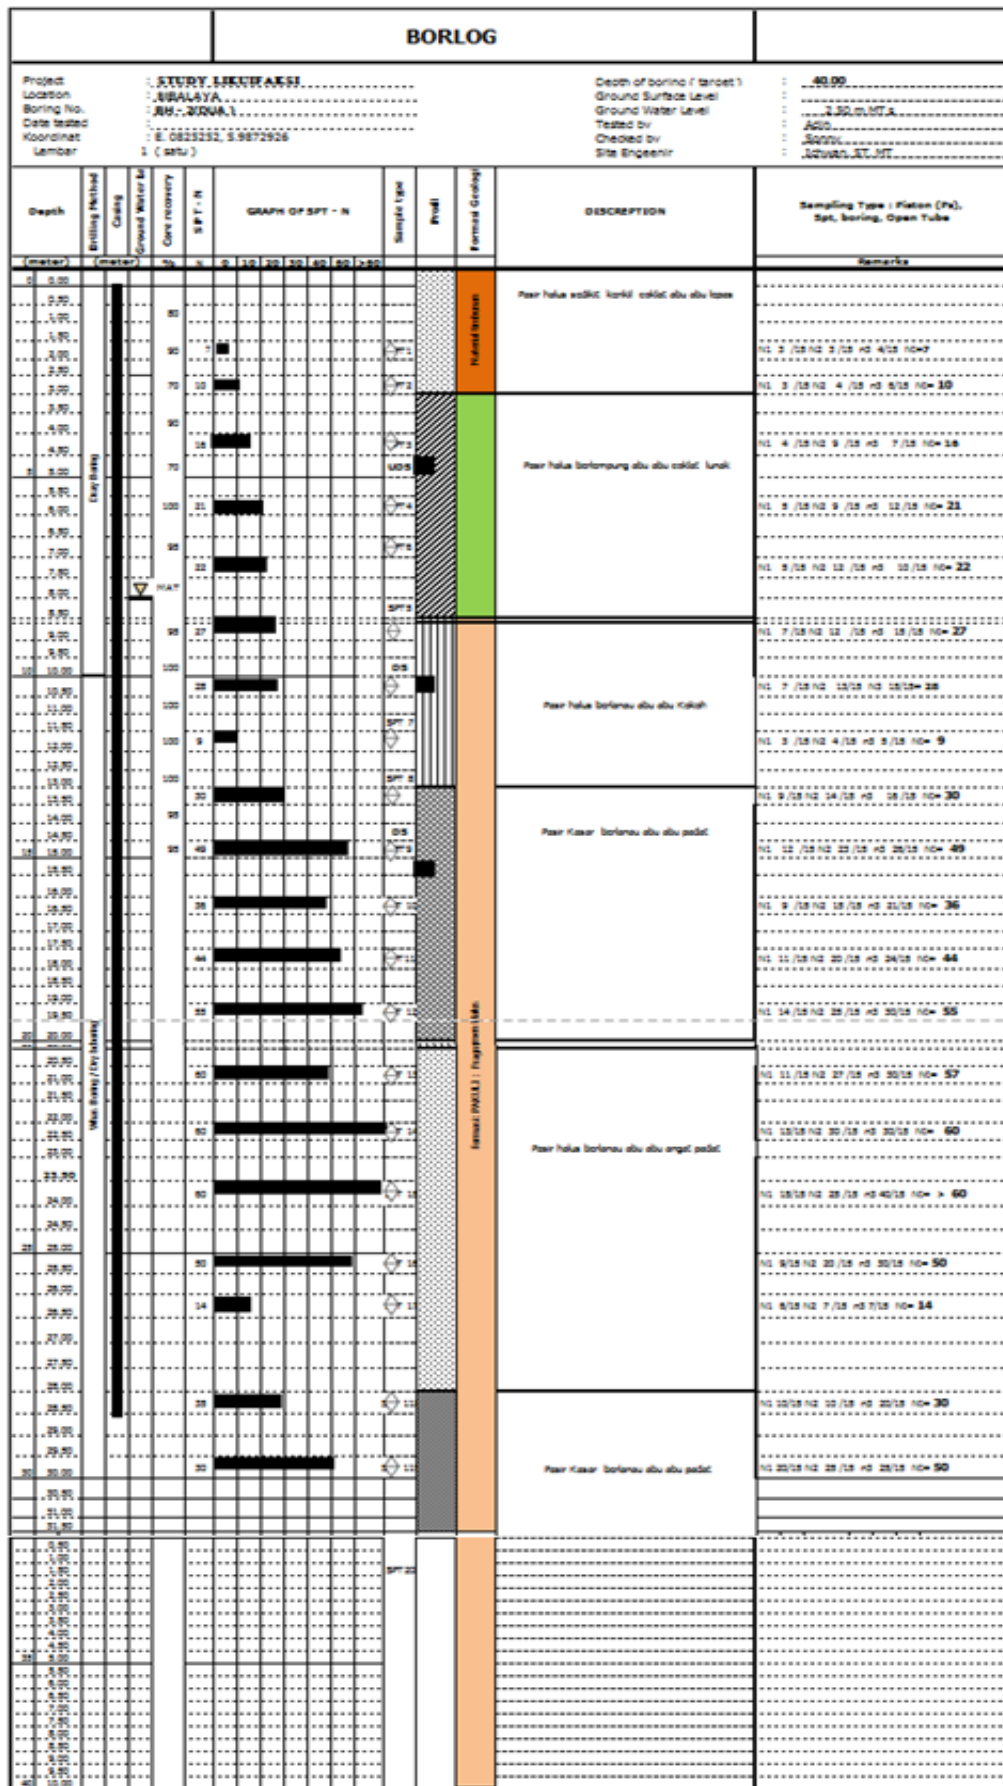
Investigations based on technical drilling (Figure 6), especially with regard to Drill -1 (detail-1) and Drill-3 (detail-3) after the earthquake occurred, showed differences in layers caused by potential faults so that Bor-1 was at depth 2-3 meters of solid rock layers are found, while in Bor-3 the soil layer has been degraded due to fault movement and saturation. This condition can be observed with the N-SPT values varying to a depth of more than 20 meters.

Figure 6 location with Molasses layer and Saturated silt sand Lapsan N-SPT value <40 varies to a depth of 20 m)

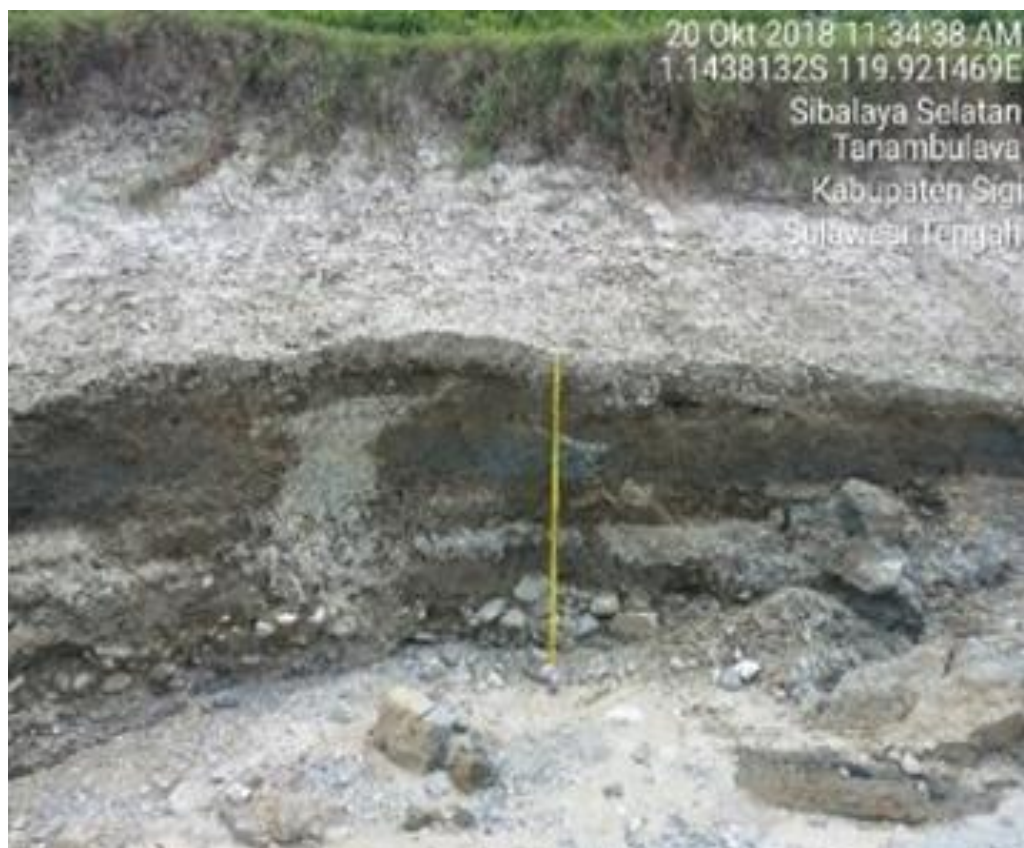
Analysis and study of the Palu Earthquake on the impact location covers the distribution area as shown in Figure 4. At the time of the field investigation, it was found that the material encountered at the disaster location was dominated by sandstone layers and conglomerate rocks that had completely degraded and their position was under silt layer sediment. is a sediment "Molasse" and not completely confined, and shown in the identified outcrops in the field (Figure 7).

This Molasse sediment is formed from the Celebes Formation which has not been completely depressed. This condition can be proven by the appearance of old mud puddles in several locations which are thought to have come out of the crack patterns that were formed in several locations. The results of the gradation analysis of the material presented [3] that this molasses material has a homogeneous gradation and is potentially unstable to water saturation.

Photo 1 Molase layer at Sibalaya

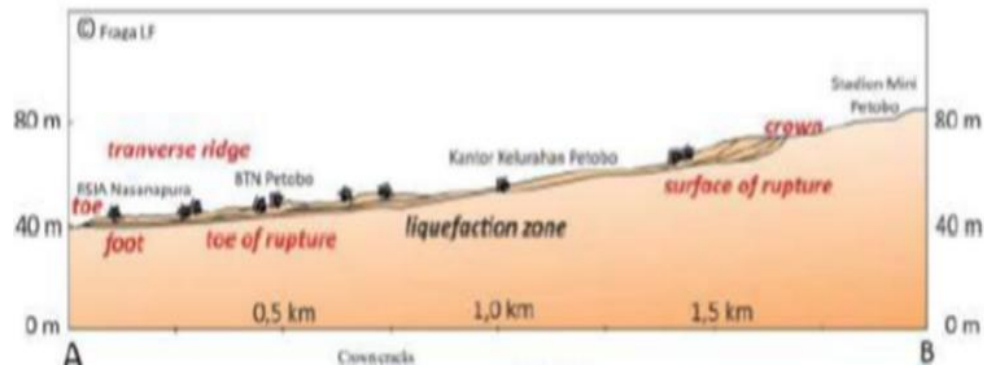
- 1) At the Sibalaya location, it is dominated by graded material dominated by a sand layer with conglomerate rock deposited mixed up between tuffaan volcanic debris and sand and weathered clay rock (Figure 8).
- 2) At the Sibalaya location, mud material consisting of clay and silt was found around the cracks with wet mud conditions due to the presence of water which is thought to be the trigger for local abrasion which is characterized by a slippery surface area.

Figure 8 Identification of the results of the study of the alleged landslide location in Sibalaya after experiencing liquefaction and translational landslides
