ASSESSMENT OF TECHNICAL CONDITION AND REINFORCEMENT OF STRUCTURES ARCHITECTURAL MONUMENT "BUKHARA WATER TOWER"

Vakhidov M.M.¹ , Safarov U.I. ²

Vakhidov M.M. , Safarov U.I. , Assessment Of Technical Condition And Reinforcement Of Structures Architectural Monument "Bukhara Water Tower" , Palarch's Journal Of Archaeology Of Egypt/Egyptology 18(4). ISSN 1567-214x.

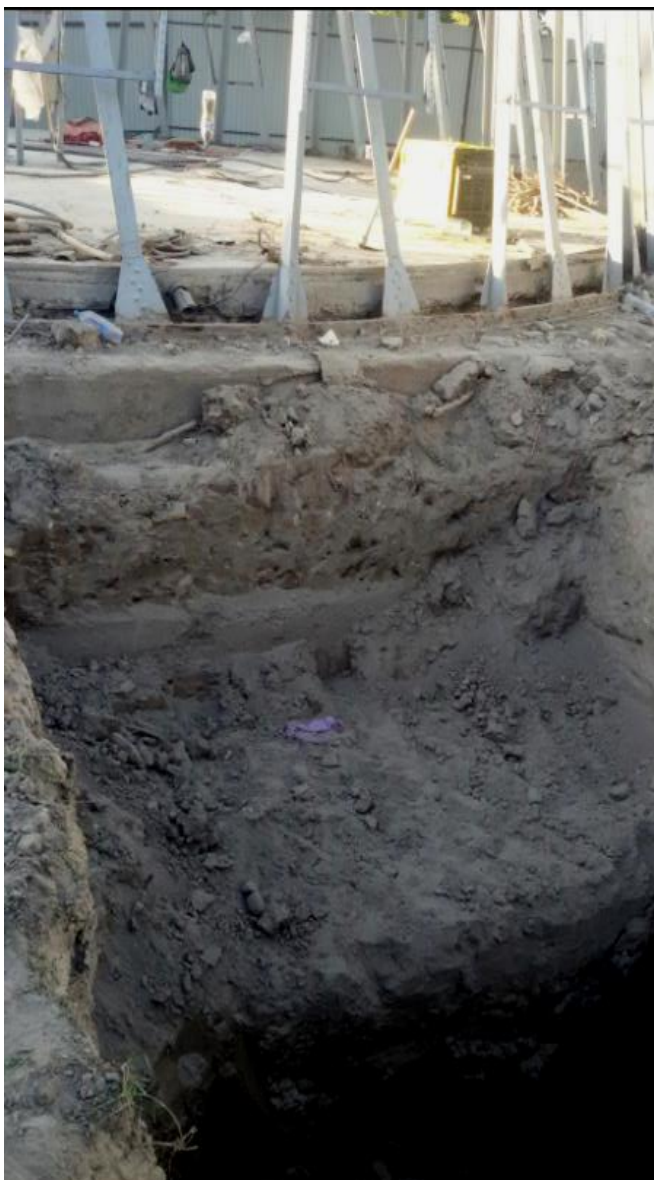
Photo 6. Fragment of the uncovered 3-stage foundation of the tower (uncovered depth of 3 m); height and width of the 1st lower step 60 and 230 cm; height and width of the 2nd middle step 50 and 50 cm; the height and width of the third upper step are 130 and 50 cm. The total width of the basement sole is 660 ($230 + 50 + 50 \cdot 2$) cm, its total height is 240 ($60 + 50 + 130$) cm.

The opening of the underground part of the structure showed that the total width of the foot of the 3-step foundation (see photo # 6) is $(230 + 230) + (50 + 50) + (50 + 50) = 660$ cm, its total height is $60 + 50 + 130 = 240$ cm. The height of the upper part of the foundation from the ledge to the bottom of the metal support ring is 130 cm; the width of the ledges in each direction is 50 cm. The height of the upper cut of the foundation, on which the metal support ring is installed, is 30 cm.

The average compressive strength of concrete, determined by the non-destructive method using the Onyx-2.5 device, is 15.4 MPa (strength class is almost B12.5). There are no signs of corrosion or other damage on the surface of the foundation.

1. The technical condition of the foundation of the structure is satisfactory. However, there is no insulation on its side surfaces; it is recommended to open the tower foundation around the perimeter and insulate its outer surfaces.

2. Around the perimeter of the foundation, it is necessary to arrange a blind area 1.5-2 m wide (behind the supporting bottom ring) with a proper slope.

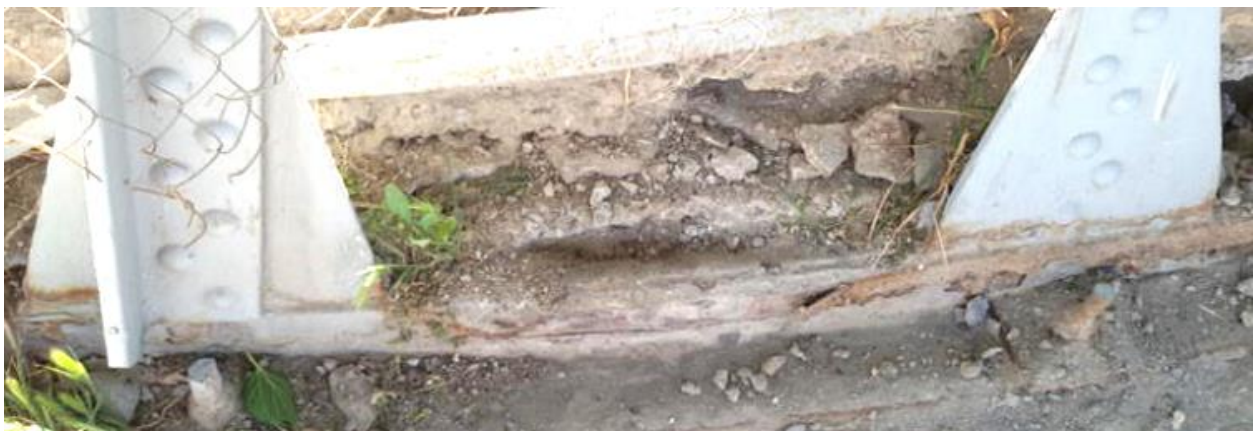
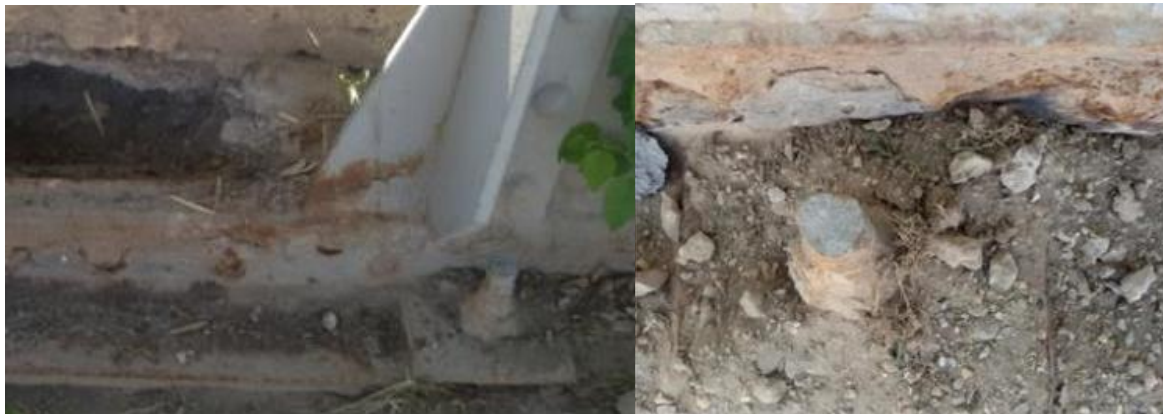
The width of the metal support ring is 30 cm, the initial thickness is 20 mm, at the present time it is 4 mm at the place of opening, i.e. corrosion destroyed metal with a thickness of $20 - 4 = 16$ mm. Between the paired coals (No. 120) there are "gussets" more than 1 cm thick. The total design thickness of the vertical rib of the support ring is 42 mm.

Photo 7. Support ring, consisting of two coals (No. 120) and gussets are attached to the foundation with bolts installed every 92 cm on both sides of the ring (a - general view, b - bolt separately; now after corrosion 19 ... 23 mm, at the same time its initial size was 25 mm) Studies have shown that the support ring is fixed to the foundation using anchor bolts with a design diameter of 25 mm (see photo # 7; during the survey of the object, the bolts were corroded and their actual diameter is about 19 mm), installed every 92 cm next to rack tower. The number of bolts on the outside is equal to the number of racks and is 52 pcs. The bolts are anchored in a monolithic foundation, they pass through the holes in the support ring and are tightened with nuts. Thus, the lower ends of the steel profiles (posts) are securely attached to the support ring.

During the operation of an architectural structure, the support metal ring has been subject to significant corrosion for 100 years (photo 9-10). Therefore, we recommended to open the support ring, clean it from corrosion, strengthen it (photo 11-12), then apply an anti-corrosion coating on its surface.

3. The metal support ring of the tower is subject to significant corrosion. It is necessary to clean the ring from traces of corrosion and apply an anti-corrosion coating to it.

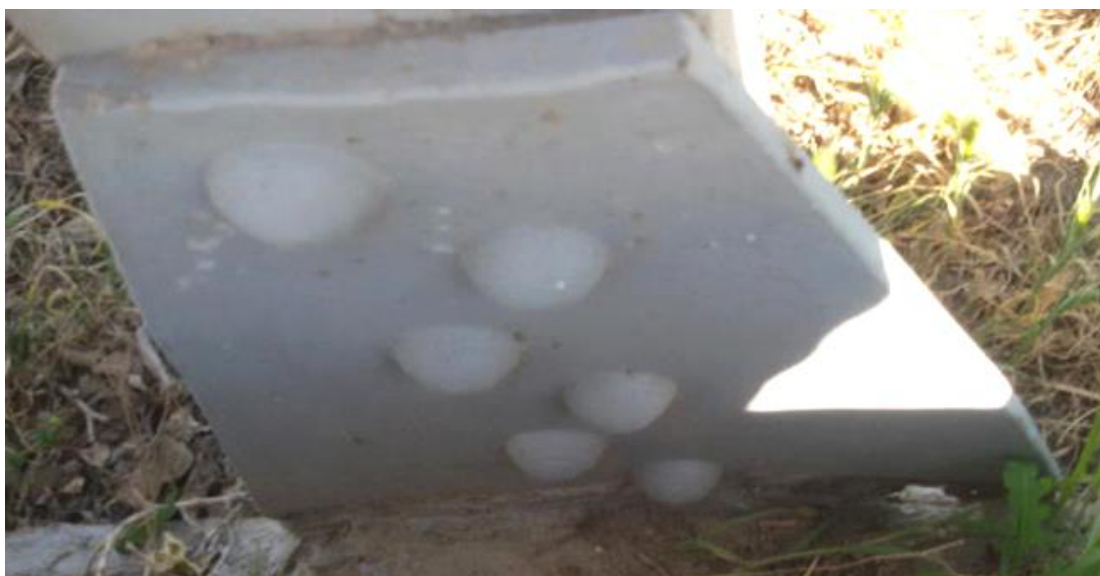
Photo 8. General view of a metal gusset, riveted with corners No. 120; by means of a gusset, the posts are riveted to the metal support ring of the tower

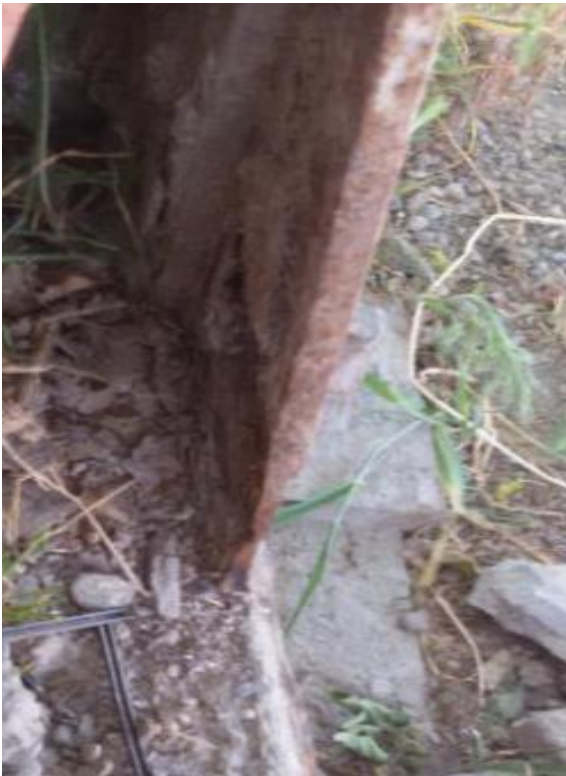
Photo 9. Fragment of the joint between the gusset and the tower support ring; the lower part of the gusset is significantly corroded, it is recommended to strengthen such places of the supporting part of the structure (before strengthening)

4. The lower parts of the vertical metal gussets used to connect the racks with the lace support structure are subject to significant corrosion, in places destroyed; therefore, a solution has been developed and the reinforcement of these structures with additional metal elements has been implemented in practice.

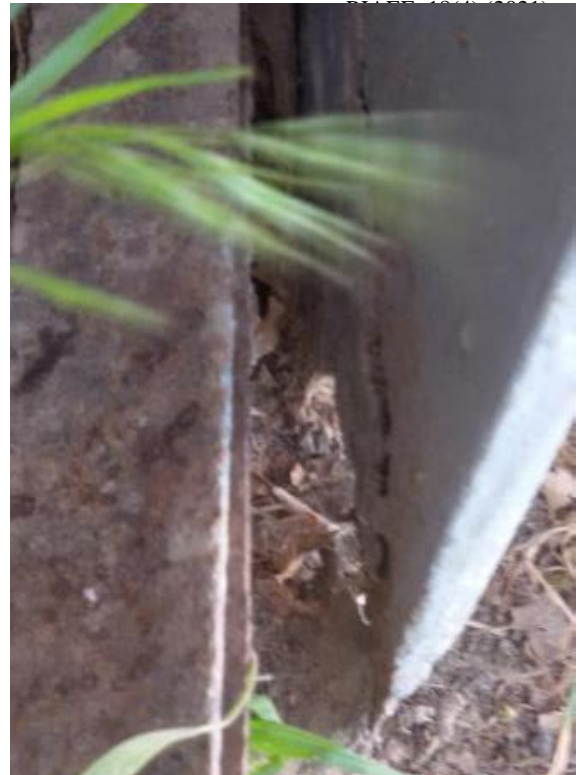
Photo 10. Fragment of the joint between the gusset and the support ring of the tower during the survey of the object the lower part of the gusset is significantly corroded, it is recommended to strengthen such places of the supporting part of the structure (before strengthening)

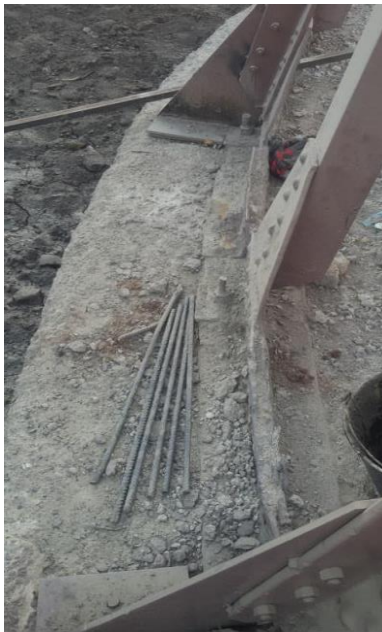
Photo 11. Fragment of the joint of the gusset plate with the support ring of the tower

after strengthening (the support ring of the tower is reinforced with metal legs, alternating in the rods in and out)

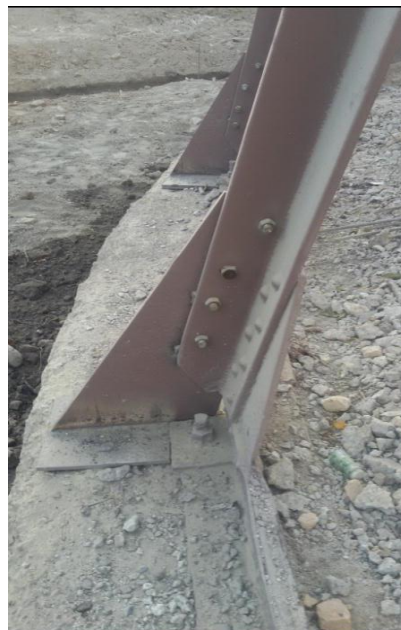
Photo 12. Fragment of the joint of the gusset plate with the support ring of the tower

after reinforcement (the support ring of the tower is reinforced with metal legs, alternating in the rods in and out)

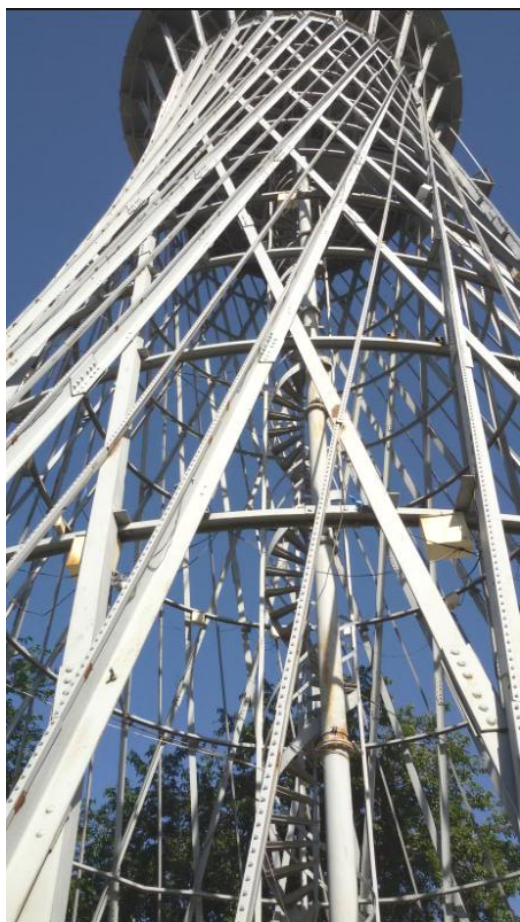
The outer surface of the tower pillar structure (photo 13) consists of 26 pairs (52 pieces) of equal-sided corners No. 120 (its actual thickness is 16 mm). The actual thickness of the gusset plates in the good parts of the structure is 12 mm.

Photo 13. General view of the outer surface of the tower, the racks of which consist of isosceles corners No. 120, interconnected by rivets (gussets are inserted at the points of contact between the coals); a water pipe is installed in the center of the site, and a service ladder is attached to it; significant damage to these elements is not observed

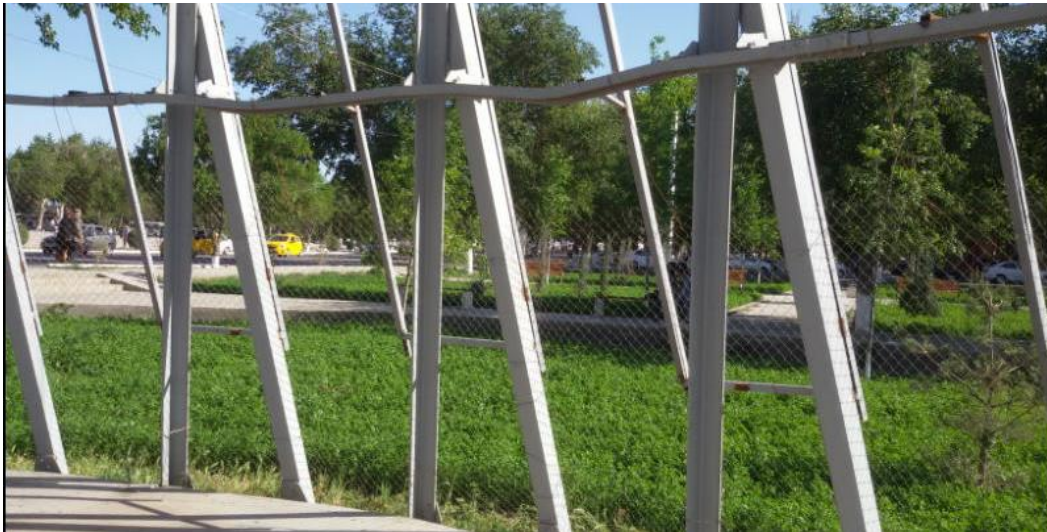
Surveys have shown that in some belts local stability losses (damage in the form of belt curvature) are observed in places. Therefore, we recommended eliminating damage to the belts of the structure, which will be carried out during the reconstruction of the object.

Photo14. A fragment of a circular belt of the 1st tier of a southern orientation, which has lost some stability

5. The technical condition of the coils serving as lace racks is generally satisfactory.
6. The technical condition of the belts made of channel bars are strongly deformed in places (there is a partial loss of stability); proposed a solution to eliminate damage to the belts.

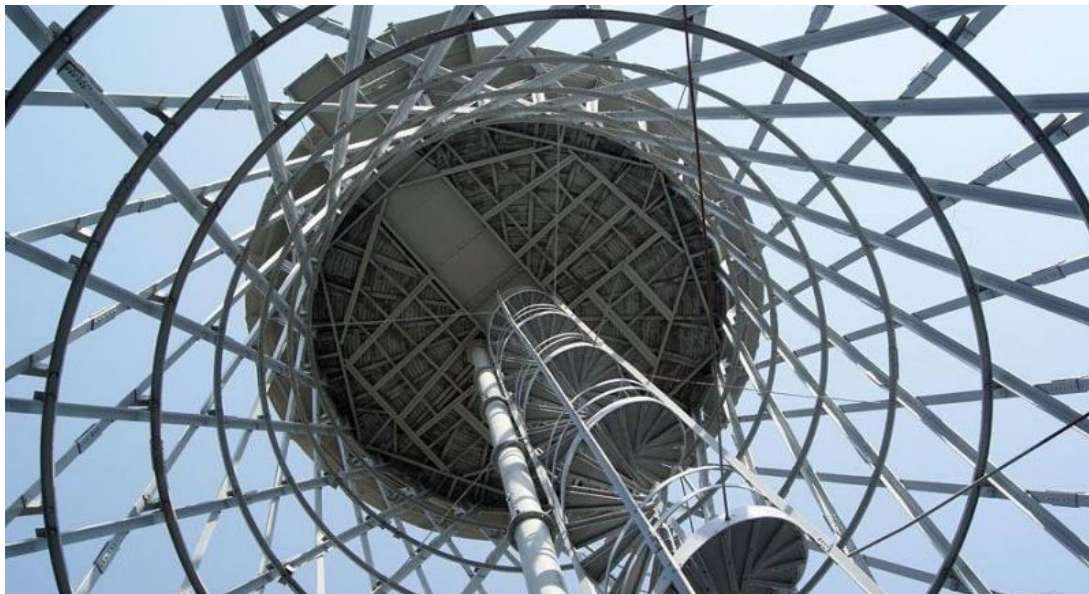
Photo 15. General view of the lower platform, rods and round belts, service ladder and tower water pipe; no significant damage is observed in these structures
