PalArch's Journal of Archaeology of Egypt / Egyptology

THE LIME COMPOSITIONS FOR TRADITIONAL BUILDING RESTORATION AND DECORATING

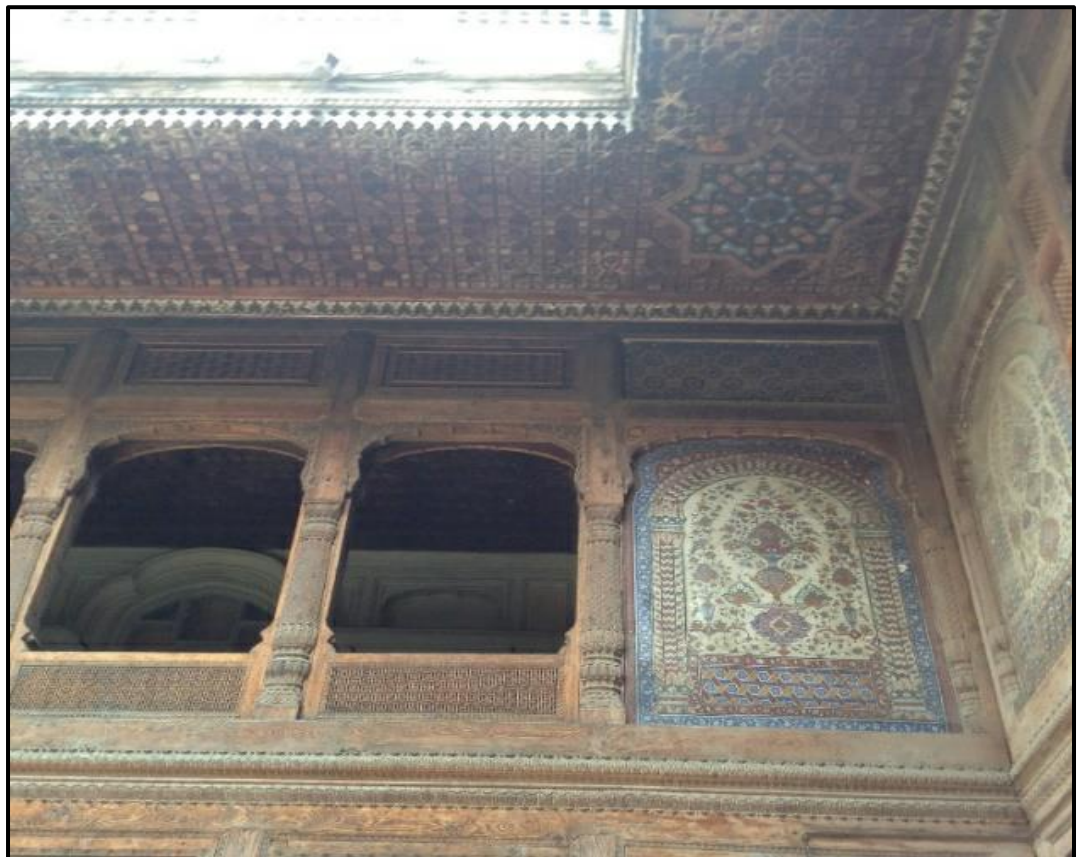
Plate.1. Intricate fresco paint bouquet design panels in the courtyard of Ahmed Gul Sethi *haveli*

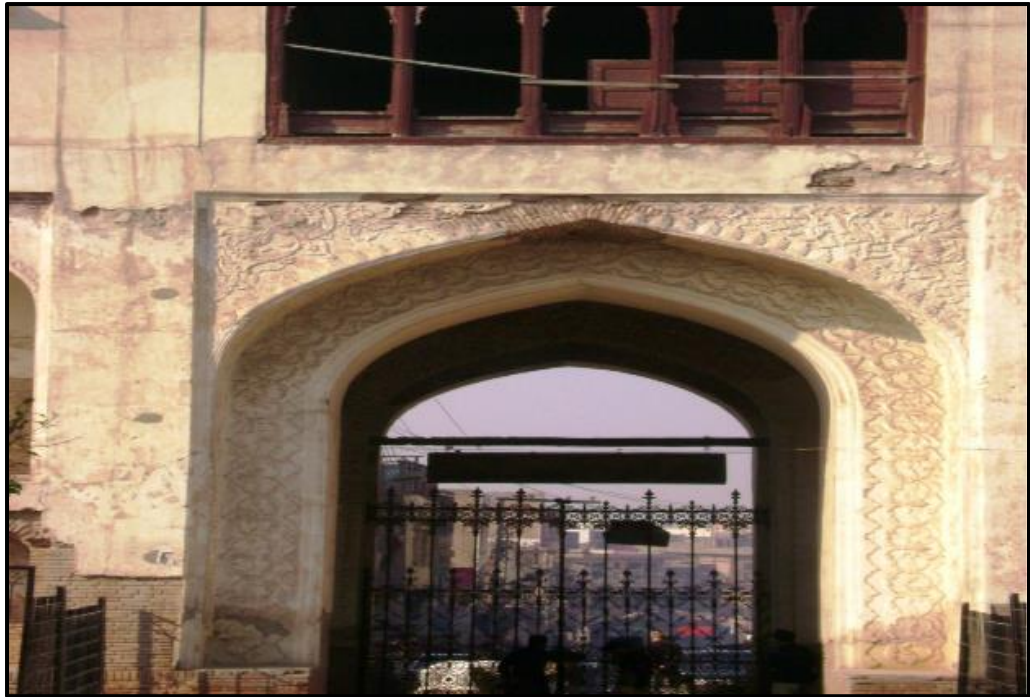
Plate.2. Stucco work (*Munabat-kari*) on western gate of Gor Khatri, Peshawar

Lime also serves as a stucco mortar, enhancing the building's appearance. The consistency of the lime, such as at Gor Khatri, Peshawar, makes the surfaces translucent and appealing to the eye (Fig.2). The delicately creative and beautifully painted frescoes are one of the most stunning decorative parts of old structures. The front façade featured the most elaborate wood carving, while the side and north walls had a lot of stucco and fresco paintings in the courtyard around the walls that were used to embellish the walls. The religious, cultural, and social values of the population, as well as their enhanced economic standing, are reflected in paintings on the exterior and interior of ancient buildings. The Mahabat Khan Mosque is richly adorned with stucco work that was created in moulds rather than being stamped (Fig.3).

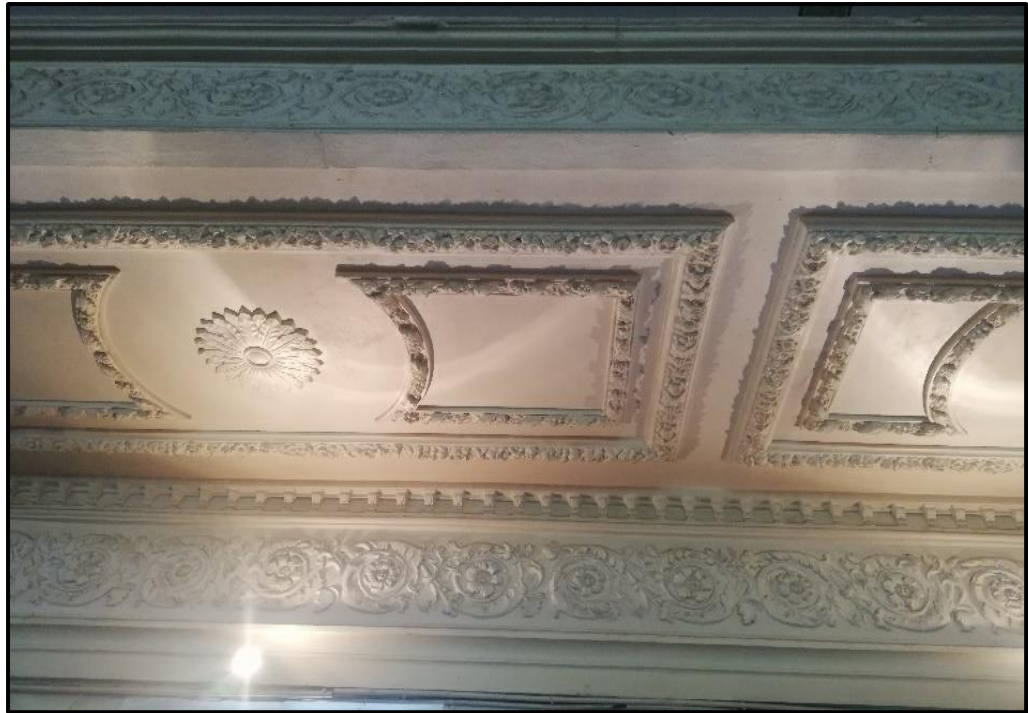
Plate.4. Stucco work (*manabat kari*) at Roose Keppel Hall, Islamia College Peshawar

The Roose Keppel hall, the Islamia College of Peshawar (Fig.4), the niche cluster (*chini khana*), and the mirror mosaic were all made by placing mirror-cut forms over wet lime and painting the ceilings with lime stucco plaster (Fig.5).

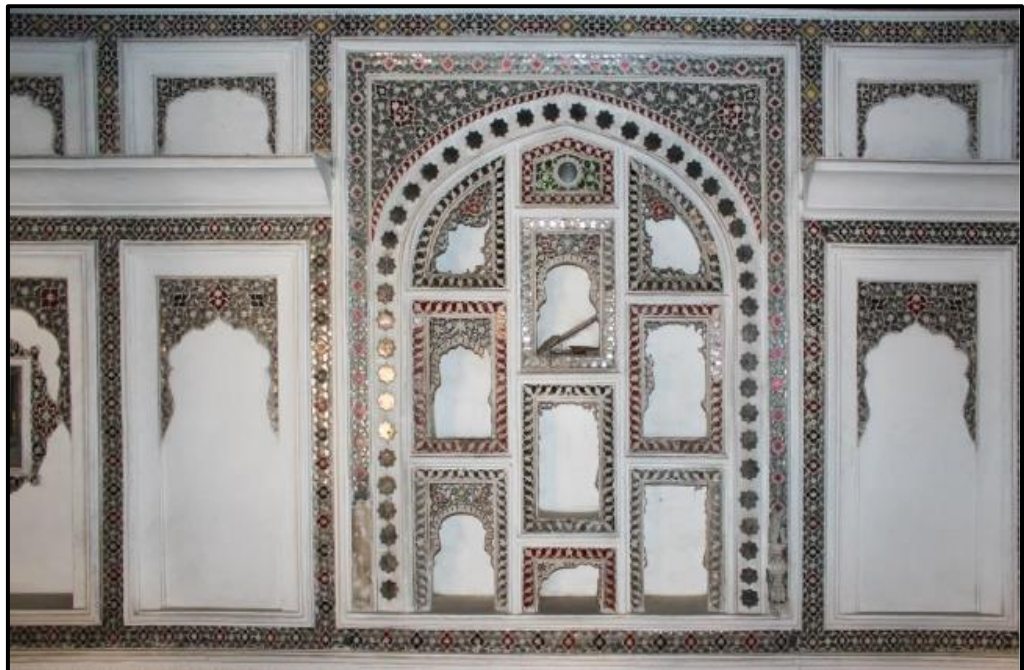
Plate. 5. Chini-khana ornamented with mirror and glass mosaic immersed in lime putty at Ahmed Gul Sethi haveli, Peshawar
