PalArch's Journal of Archaeology of Egypt / Egyptology

CONSERVATION AND RELOCATION PROJECT OF THE TELUK MEMALI MOSQUE

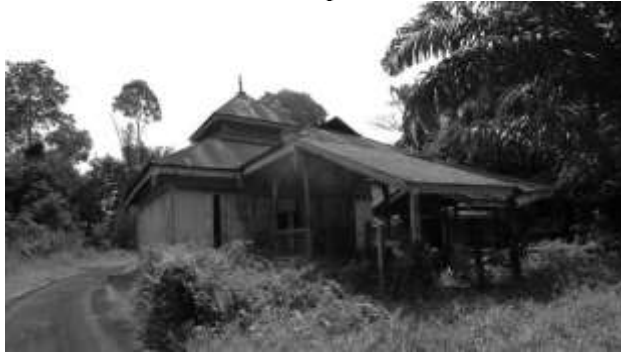
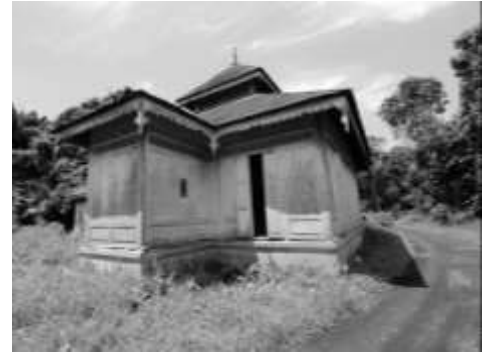
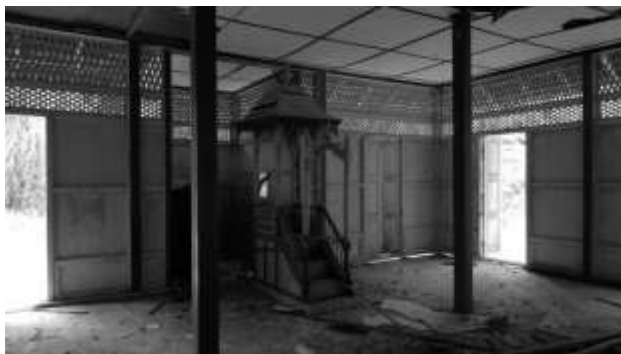
Fig. 1- Conditions of Teluk Memali Mosque before the conservation. Above left picture; front side of the mosque, above right picture; *mihrab* area, and below picture; interior view of the mosque.

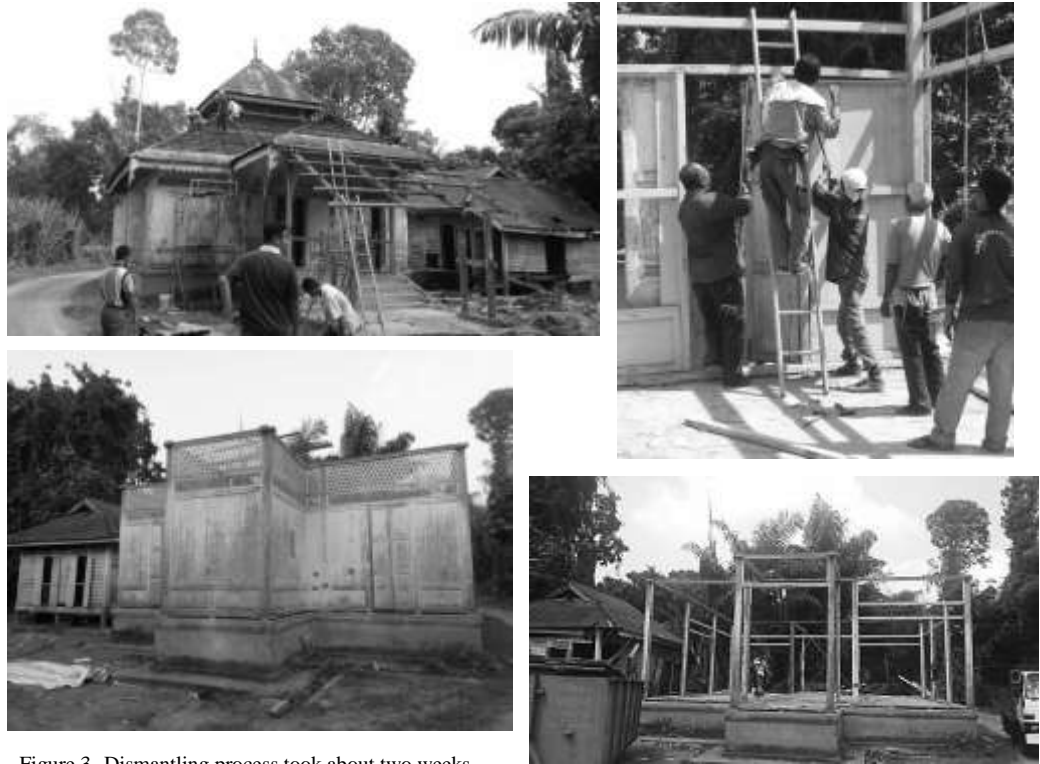
Figure 3- Dismantling process took about two weeks.

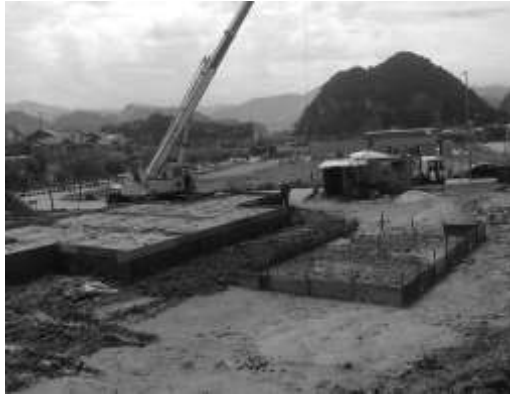
Fig. 4 - Preparation of concrete base based on the original size and height.

All treated building components were transported to the new site periodically and stored in a temporary tent. A concrete platform was built as the mosque base with the same specifications of height and width on the old site. 14 wall plugs were planted on the concrete platform at each column point to a depth of 200 mm (7.8 inches) and 100 mm (3.9 inches) above the surface. The reconstruction of Teluk Memali Mosque began with the installation of columns through a slot-in method which included a wall plug into a hole that was readily punched in the column base. This method was vastly different from the original construction which saw the whole structure sits on the platform. This is because the original columns are believed had been cut to replace the elevated floor with a podium floor. The wall plug method was also applied to increase the resistance of the structure due to the strong wind conditions of the new site.

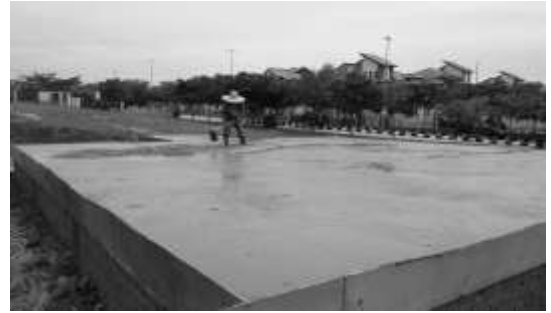
Figure 5 - The reinstallation process of the building elements and components of the Teluk Memali Mosque

Generally, all of the building components were painted prior to reinstallation works, except the wall panels. This was done to assist the reinstallation process and painting work, especially for complicated elements such as the ventilation panels and the height issue as well as to prevent the paint spills and smudges on the wall panels. During the reinstallation period, there were some other works tasked simultaneously, such as the repair of the ablution water trough, construction of *balai lintang* (annexe hall), earthworks, drainage and site pavement. Soon after the completion of reinstallation and construction works, the subsequent landscaping work, electrical connection and the water supply system were done. The summary of reinstallation works of the Teluk Memali Mosque is shown in Figure 5 below.

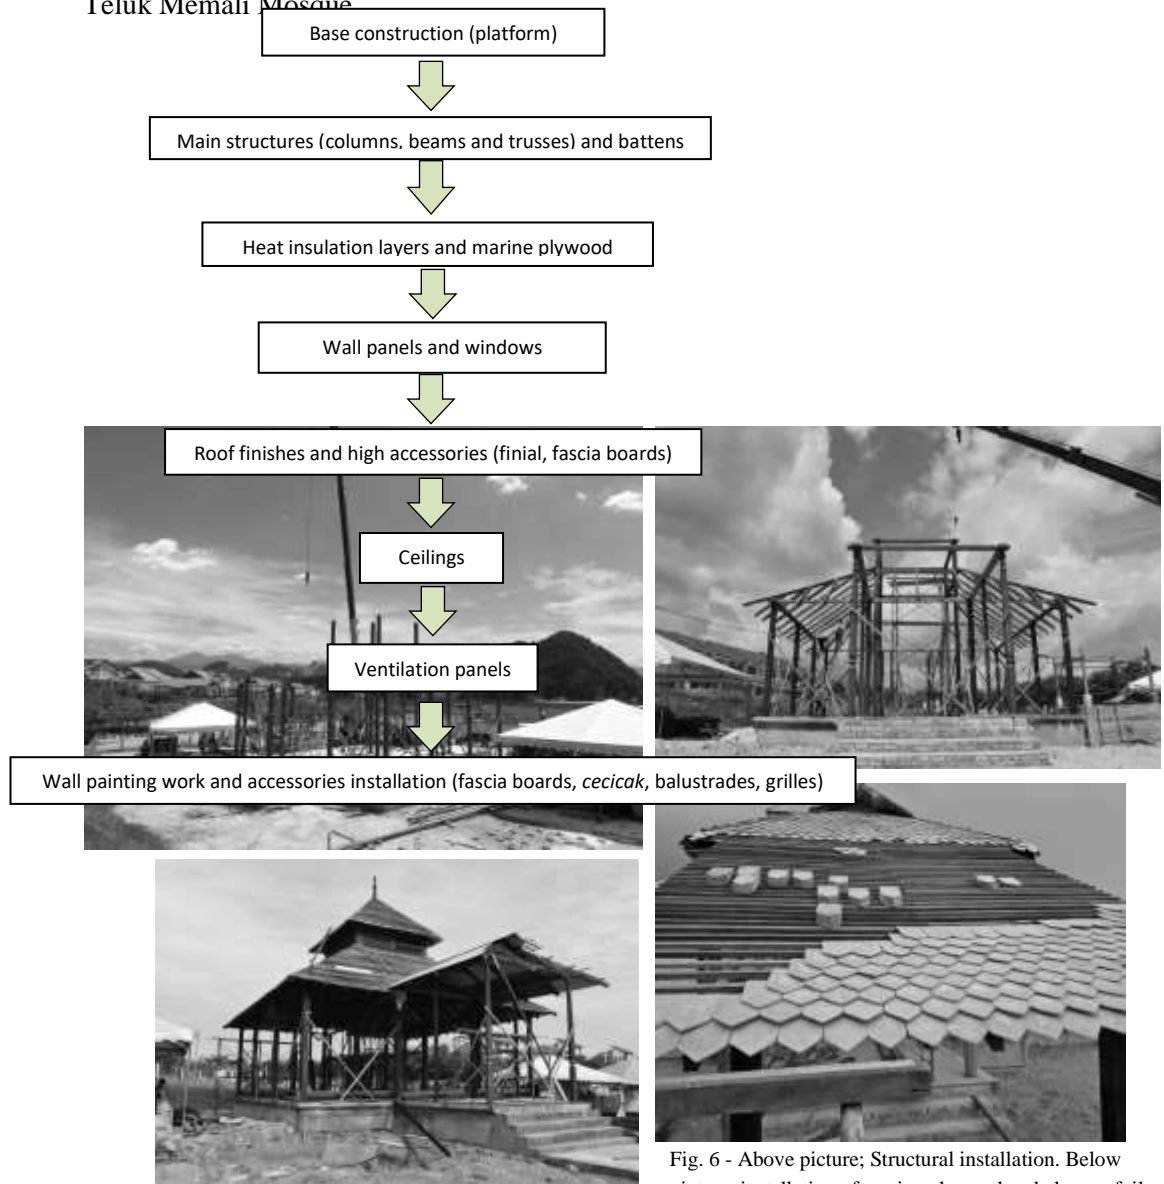
Fig. 6 - Above picture; Structural installation. Below picture; installation of marine plywood and clay roof tiles.

Installation works were continued with other building structures such as roof beams, trusses, battens and door sills. The roof elements were further added with heat-resistant insulation layers and also marine plywood to address leakage issues in the future, as well as to allow maintenance works to be executed easily even without roofing. The reinstallation works, then continued with wall panels and windows. The clay roof tile fitting was done simultaneously with the installation of finial and fascia boards of the jack roof. Then, it was followed by the installation of ceiling boards finished with paint layers. The painted ventilation panels were put on the upper part of the walls followed by the painting works of the whole wall panels. The final stage of the reinstallation involved building accessories such as fascia boards, *cecicak* carving, carving panels, handrails and balustrades with window grilles.

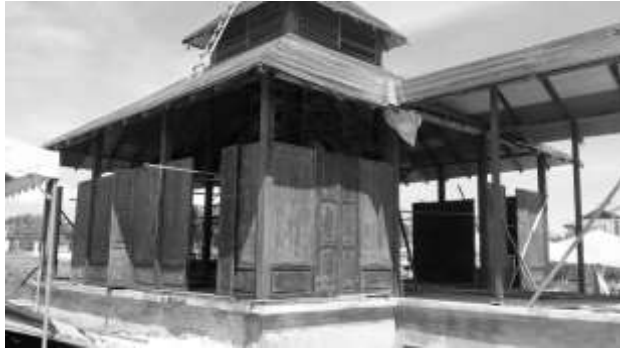
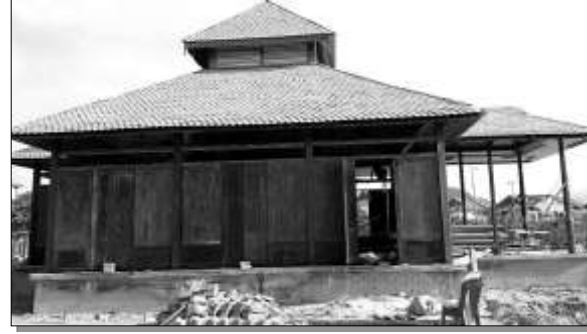
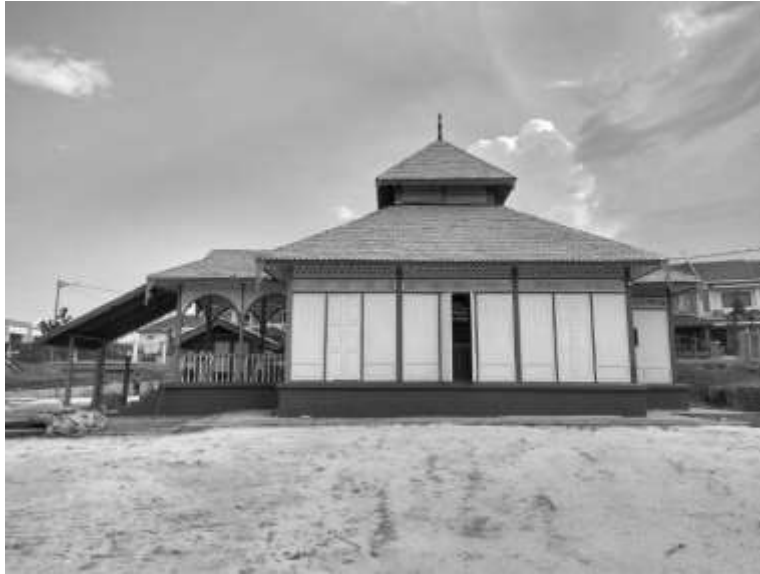
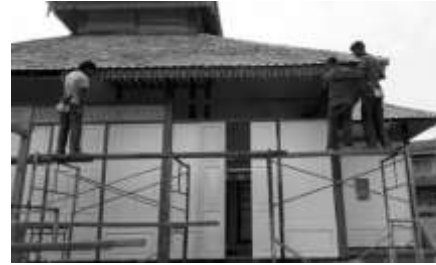
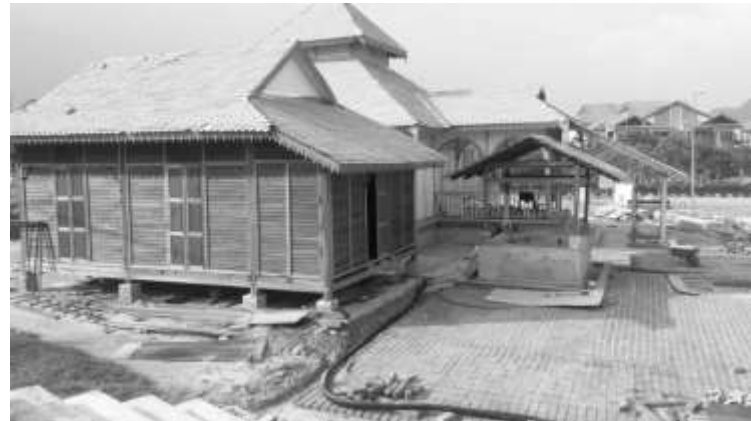
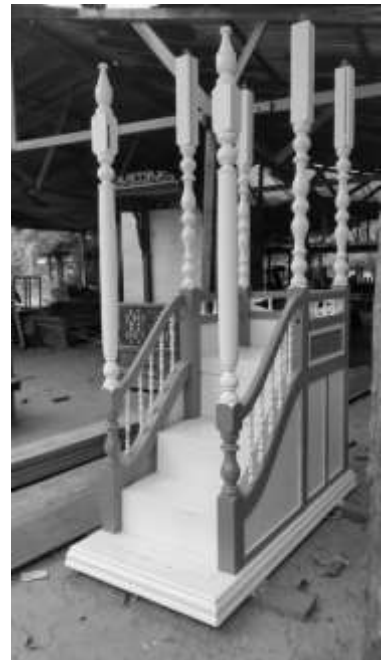
Fig. 7 - Pictures show the installation works of building elements and components of Teluk Memali Mosque including the fascia boards, *mimbar* treatment, *balai lintang* construction and landscaping work.

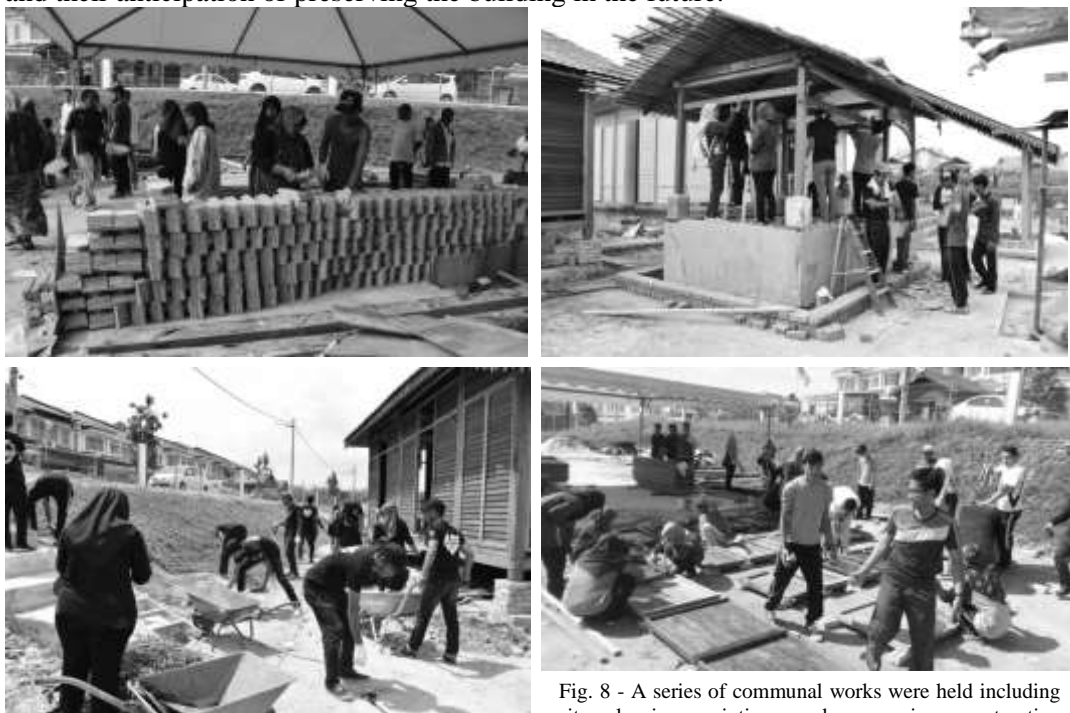
Fig. 8 - A series of communal works were held including site cleaning, painting work, arranging construction materials, painting of anti-termite layers and water repellent. These activities were participated by the local communities, students and individuals.

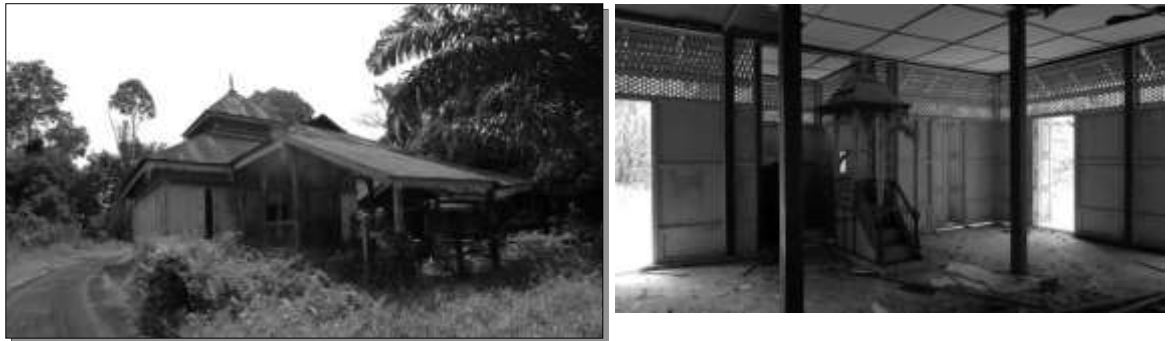
Fig. 9 - Teluk Memali, Gajah, Perak (before)

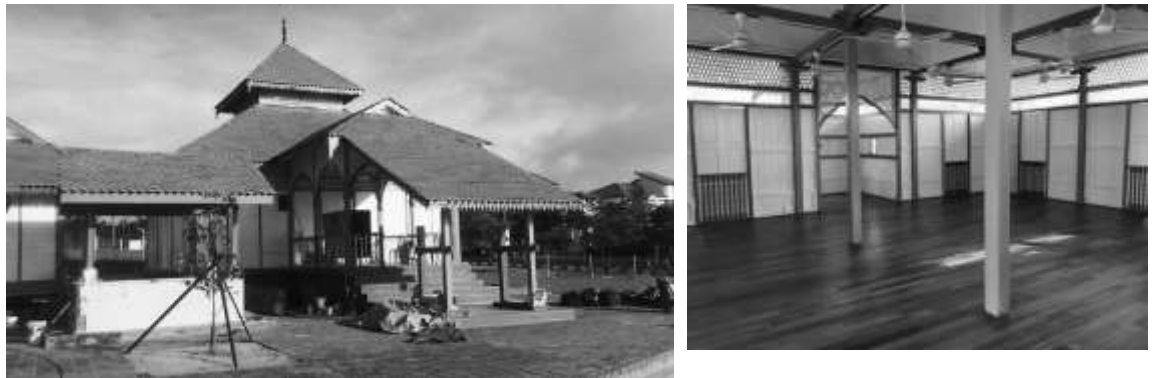
Fig. 10 - Taman Seri Bougainvillea, Bandar Seri Botani, Ipoh, Perak (after)
