THE IMPORTANCE OF DOCUMENTATION OF THE HISTORICAL HERITAGE AT RISK OF THE EARTHQUAKE WITH AN INSIGHT TO CASE STUDIES FROM ALL OVER THE WORLD

Shahrokh Pourbeyranvand

**Shahrokh Pourbeyranvand: The importance of documentation of the historical heritage
at risk of the earthquake with an insight to case studies from all over the world --
Palarch's Journal Of Archaeology Of Egypt/Egyptology 18(4), ISSN 1567-214x**

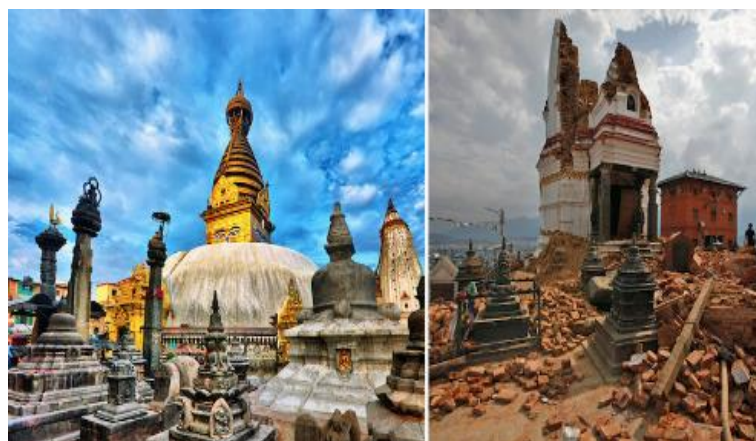
Fig. 3: Swamp Temple before (left) and after (right) of the 2015 Nepal earthquake (internet photo)

Swiambonath is a fifth-century temple called the Temple of the Monkey (Wikipedia) because of the population of sacred monkeys that live in it. Figure 3 shows this ancient religious complex before and after the April 25 earthquake. Also, satellite images taken by Google before and after the earthquake are shown in Figure 4.

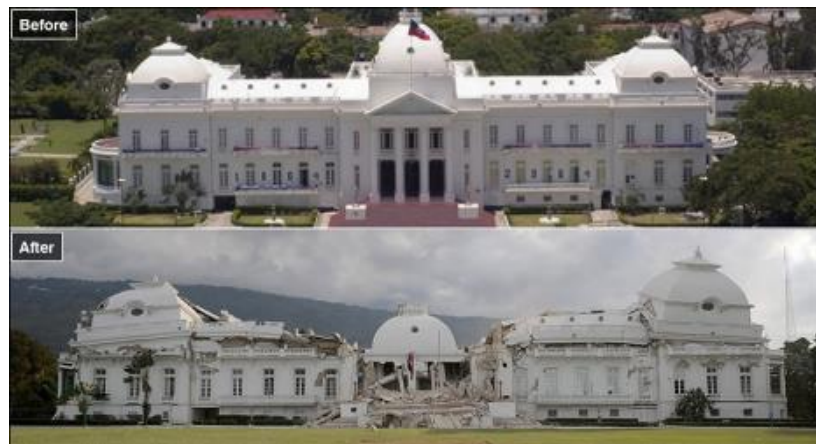
Fig. 8: Haiti National Palace before (above) and after (below) of the 2010 earthquake (photo from the Internet)

The National Palace was the official residence of the President of Haiti, located in Puerto Prince. The building was severely damaged in an earthquake in 2010. The building's ruins were demolished in 2012 and a plan has been drawn up to renovate the palace in 2017 (Wikipedia). Figure 8 shows the pre-earthquake and post-earthquake photographs of the building and satellite images using Google Earth (Figure 9).

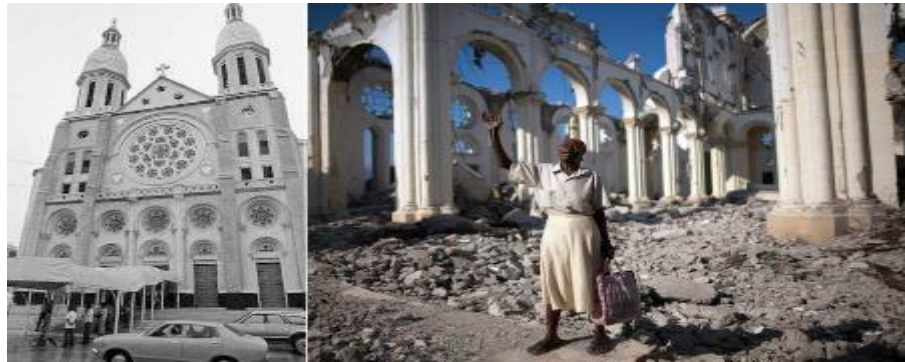
Fig. 10: Our Lady of Porto-Cathedral Cathedral (left) and after (right) of the 2010 Haiti earthquake (photo from the Internet)

Our Lady Cathedral, often referred to as the Port-au-Prince Cathedral, was the cathedral in this Haitian capital. The church was built between 1884 and 1914 and, on December 13, 1928, became the Catholic Bishop of Porto Prince. The cathedral was destroyed in the earthquake of January 12, 2010 (Wikipedia). Figure 10 shows photos of the building as

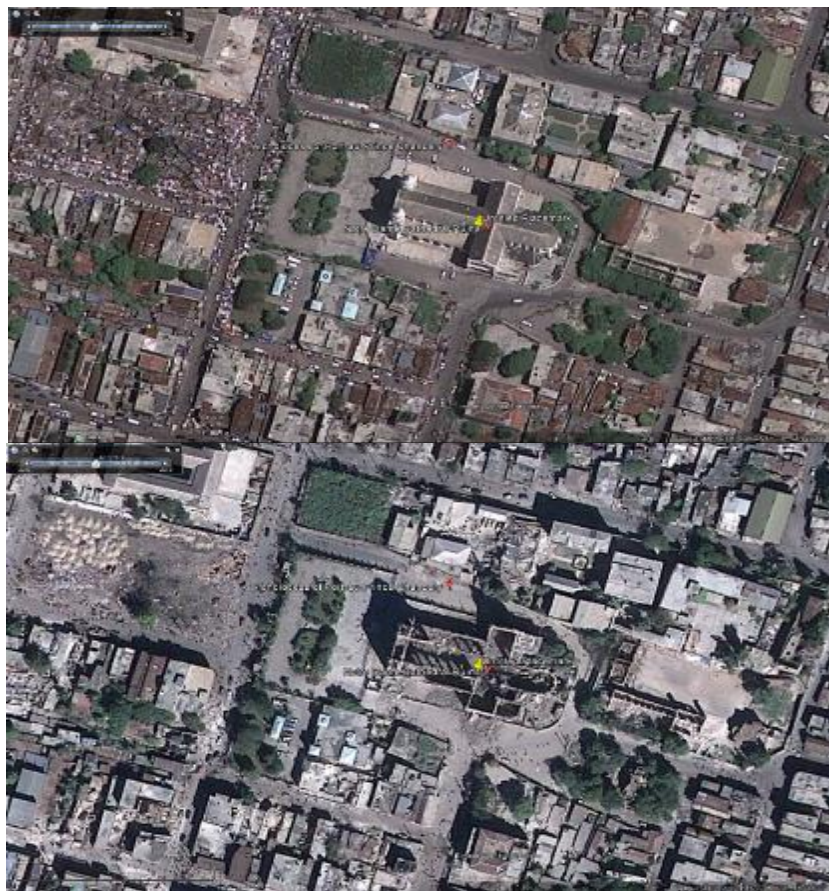
Fig. 11: Satellite Photo of Our Lady of the Cathedral, Before (Up) and After (Down) from the 2010 Haiti Earthquake (Google Earth)

well as satellite images using Google Earth before and after the earthquake (Figure 11).

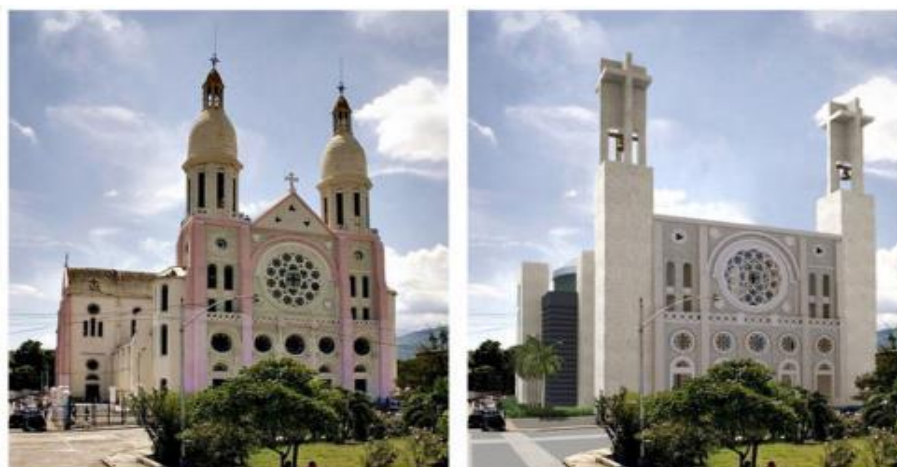
Fig. 12: Our Lady's Cathedral before the 2010 Haiti Earthquake (left) and after the Reconstruction (right) (Internet photo)

The image of this monument after reconstruction with the snapshot taken before the 2010 earthquake is shown in Figure 12. As shown in the picture, despite trying to keep the building's specifications, there are significant differences in terms of architecture between these two buildings, which could have been minimized if documented correctly and accurately.

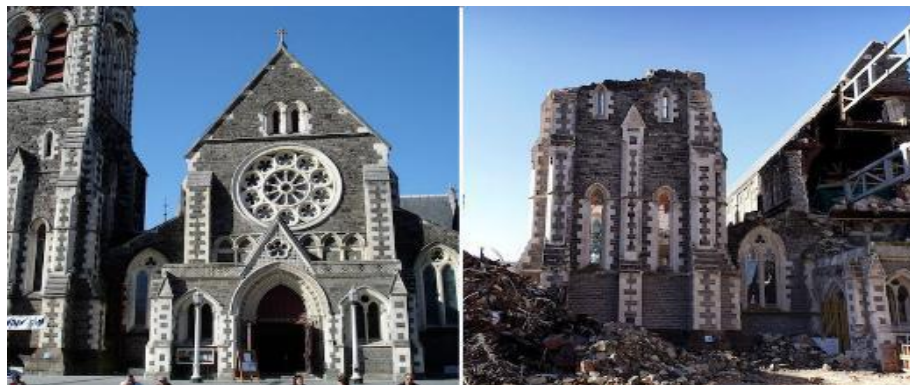
Fig. 14: Christchurch before (left) and after (right) the 2011 earthquake in New Zealand (photo from the Internet)

Figure 14 shows photos of the building and Figure 15 demonstrates satellite.mages using Google Earth before and after the earthquake.

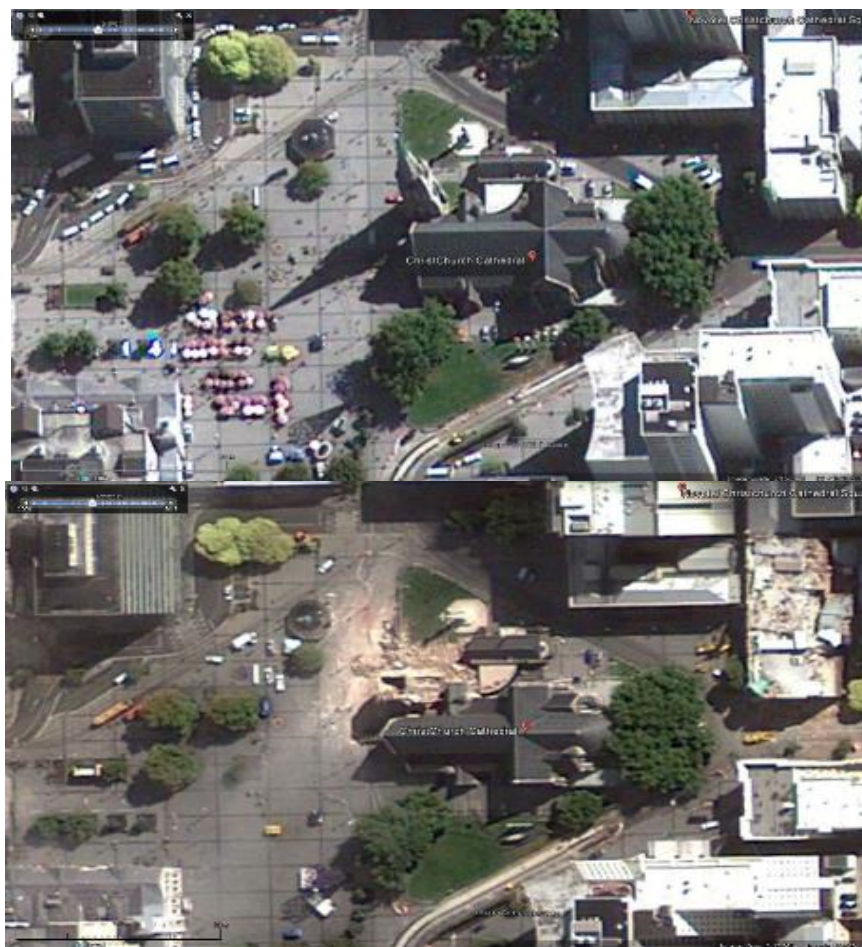
Fig. 15: Satellite image of Christchurch, before (above) and after (below) of the 2011 earthquake in Zealand

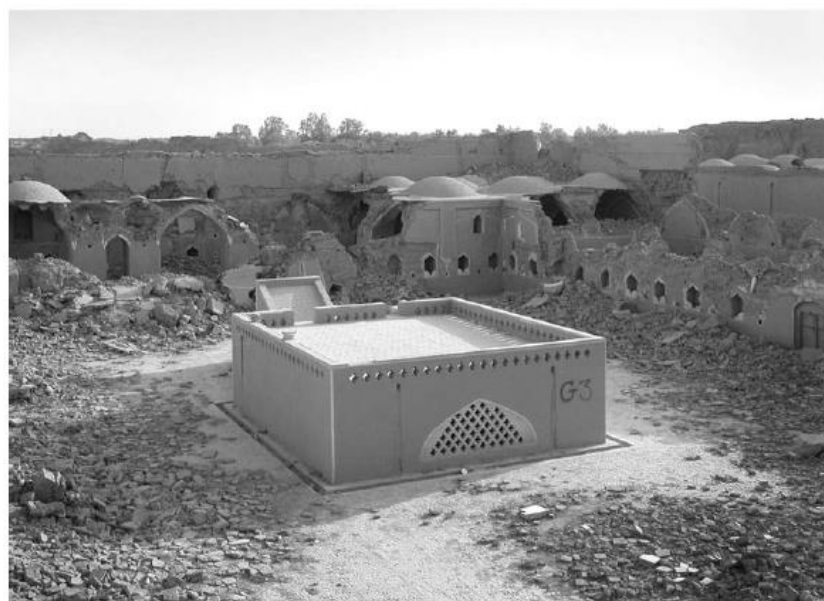
Fig. 18: An example of damage to the buildings of the Bam Citadel complex before (above) and after (below) the 2003 Bam earthquake (Langenbach, 2005)

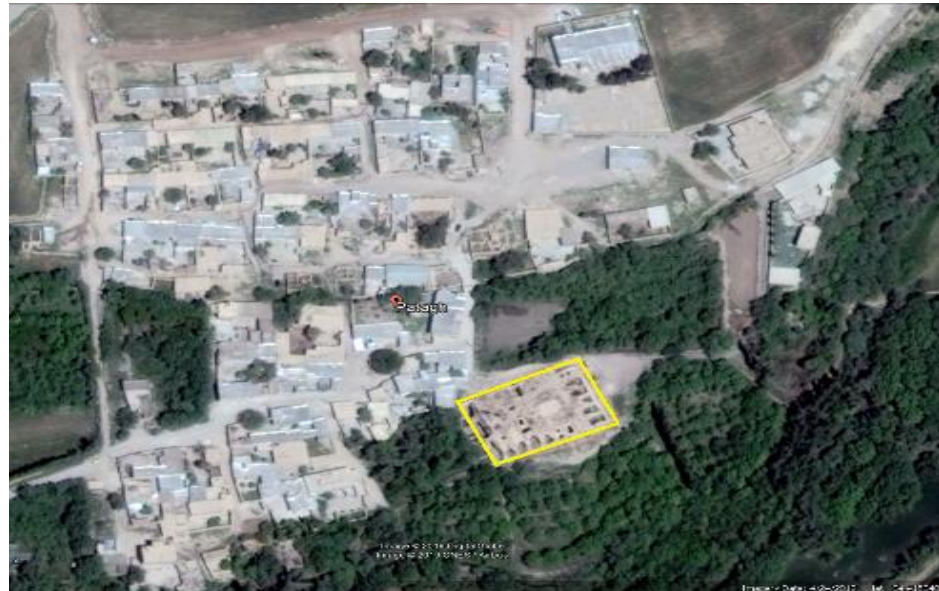
Fig. 21: Satellite image of Zij-e Manijeh from the damaged historical monuments in the earthquake of 2017 Sarpol-e Zahab (Google Earth)

Figure 21 shows Zij Manijeh or Manijeh Castle's satellite image, a historical building located in Kermanshah province, Sarpol-e Zahab city,

Patagh village, about 15 km from this city. This historical monument was registered in 2005 by the Cultural Heritage Organization with the number 13410 in the list of Iran's national monuments (Wikipedia). The damage was caused to this historical monument due to the Sarpol-e-Zahab earthquake in 1396. Unfortunately, due to the lack of access to satellite images after the quake, it is impossible to assess the amount of damage caused by this method.

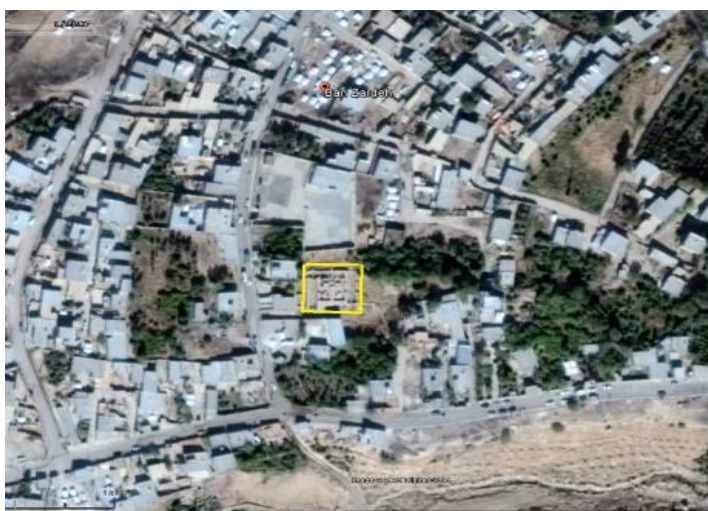
Fig. 22: Satellite image of Yazdgerd Castle from the damaged historical monuments in the earthquake of 2017 Sarpol-e Zahab (Google Earth)

Yazdgerd Castle refers to a collection of buildings related to the Sassanid period in the village of Zardeh in the city of Dalahou in Kermanshah province. Yazdgerd Castle complex is located 18 km from Rijab to Sarpol-e Zahab intersection in Kermanshah province. A Canadian Archaeological Board carried out the first archaeological excavations in the area before the Revolution. At first, the construction of this complex was attributed to the Sassanid period. Still, later excavations showed that many buildings in this area belong to the late Parthian period (Wikipedia). Figure 22 shows a satellite image in the Google Earth software before the 1396 Sarpol-e-Zahab earthquake. Unfortunately, post-earthquake satellite imagery is not available on this platform.
