PALU EARTHQUAKE CASE STUDY: INDUCING AND PRINCIPLE OF ITS COUNTERMEASURES

Sandy Radhitya Akbar¹, Eddie Sunaryo², Asep Setiawan³

^{1,2,3}Civil Engineering Department, Faculty of Engineering, Widyatama University, Indonesia

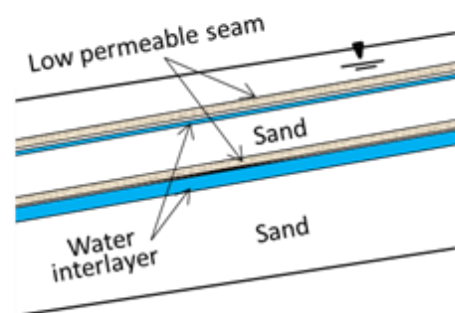
Figure 7 Potential Soil types that have the potential for liquefaction and landslides [4]

- 1) Stratification of the soil layer consists of a layer of sand with a low permeability value and there is an interface layer with the layer below which has a high permeability value and contains a significant change between the original and saturated state or the stress that occurs has become "residual stress"
- 2) Slope will affect the movement of saturated material after liquefaction and movement according to the load to gravity and the increase in water pressure is
- 3) The slope movement is getting steeper, the faster it is and can reach a maximum of 4 m as the lateral flow on slopes reaches 1% [4]. The more vertical the slope, the tsunami does not occur because landslides occur due to the warranty.

Void redistribution in layered sand
