ASSESSMENT OF TECHNICAL CONDITION AND REINFORCEMENT OF STRUCTURES ARCHITECTURAL MONUMENT "BUKHARA WATER TOWER"

Vakhidov M.M.¹ , Safarov U.I. ²

Vakhidov M.M. , Safarov U.I. , Assessment Of Technical Condition And Reinforcement Of Structures Architectural Monument "Bukhara Water Tower" , Palarch's Journal Of Archaeology Of Egypt/Egyptology 18(4). ISSN 1567-214x.

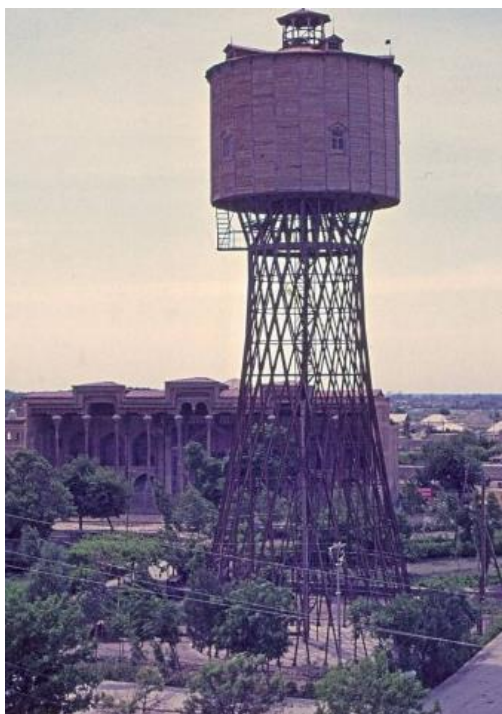
Photo # 1. General view of the Bukhara water tower after construction; at a height of +25.2 m there was a water tank, which had a maximum diameter of 6.5 m, its height was 4.2 m. Above the tank there was a platform for observing the surroundings, to which one could climb a spiral staircase.

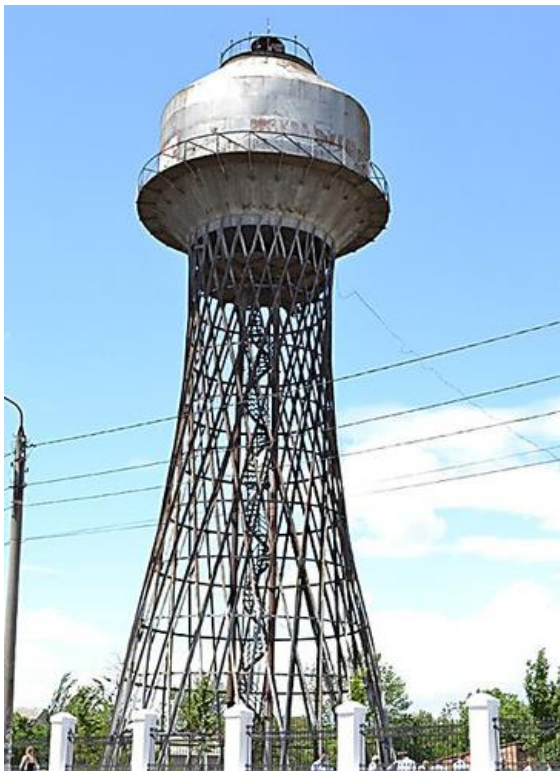
Photo # 2. General view of the water tower in the 1970s

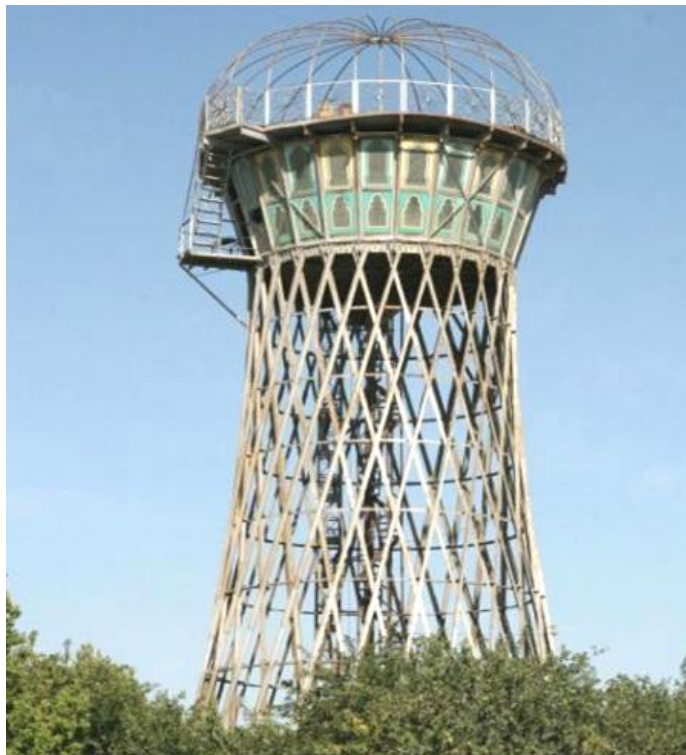
Photo # 3. General view of the tower in the 2000s during its use as a restaurant (lower tier) and an observation deck (upper tier)

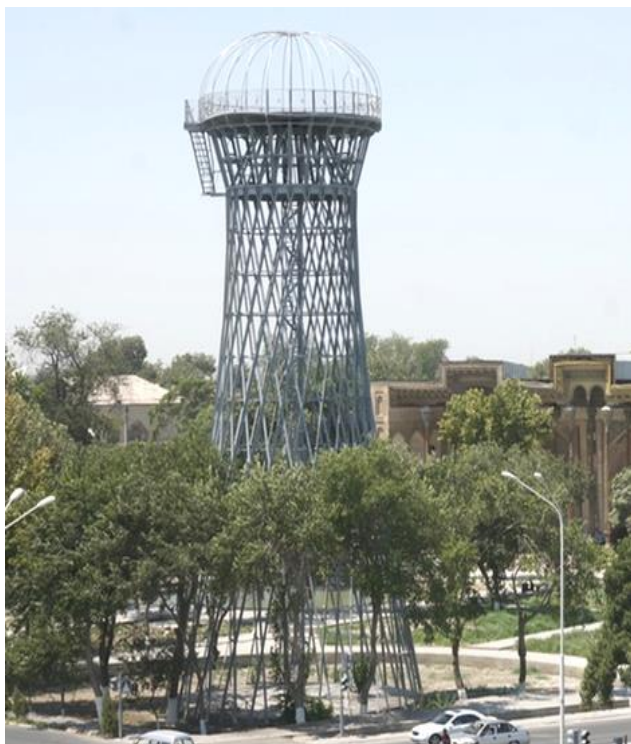
Photo # 4. General view of the tower in the 2000s during its use as an observation deck

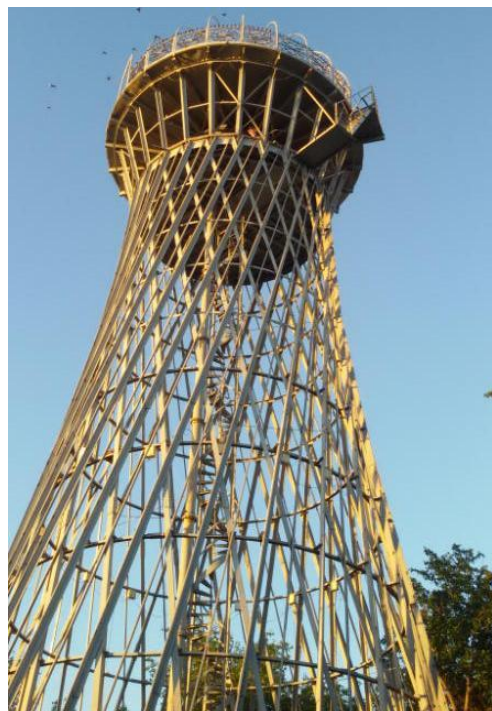
Photo # 5. General view of the tower at 1.05. 2018; it is currently being reconstructed in order to organize an observation deck
